ENGINE COMPONENTS AND FILTERS: DAMAGE PROFILES, PROBABLE CAUSES AND PREVENTION

Technical Information

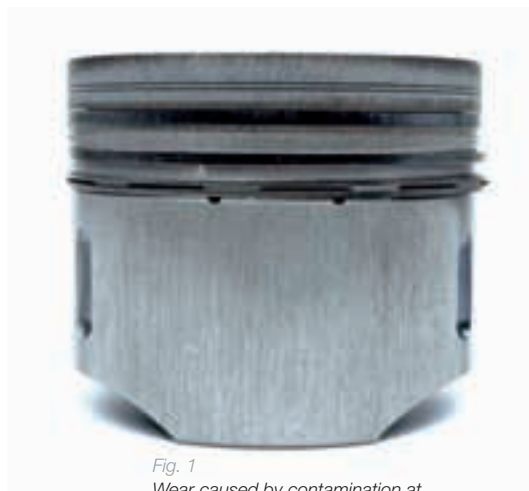
- The piston skirt displays a scuffing, wide wear pattern on the thrust and opposite side (Fig. 1).
- The machining profile at the piston skirt (Fig. 2) and at the contact surfaces (cylinder wall or cylinder liner) has been removed (Fig. 3).
- The piston skirt, piston rings, cylinder wall and/or cylinder liner display fine scoring marks in the running direction.
- The piston rings and groove walls are heavily worn (Fig. 4).
- There is a large end gap at the piston rings. The edges of the rings are razor sharp.
- The faces of the oil control ring are worn (Fig. 5).
- The piston pin shows longitudinal scoring marks with a wavelike profile (Fig. 6).
- Wear caused by contamination can also be found on other components, for example at a valve stem (Fig. 7).

... and the top ring is more worn than the oil control ring, contamination has reached the combustion chamber via the intake system of one cylinder, i.e. from above. This is caused either by a leak or debris which was not removed prior to assembly.

... and the top ring is more worn than the oil control ring, contamination has reached the combustion chamber via the common intake system of all the cylinders. This is either due to leaks and/or a defective or missing air filter.

... and the oil control ring is more worn than the top ring, contaminated engine oil is the culprit. The oil is contaminated either due to an uncleaned crankcase and/or a dirty oil mist separator.

Fig. 1
Wear caused by contamination at the piston – longitudinal scoring marks

- Check the intake system for leaks.
- Check the air filter and, if necessary, replace it.
- Clean the crankcase and the intake manifolds prior to assembly.
- Always pay attention to cleanliness during assembly.

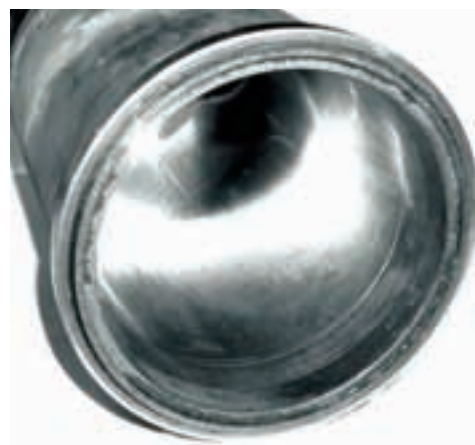
Fig. 3
Worn cylinder liner

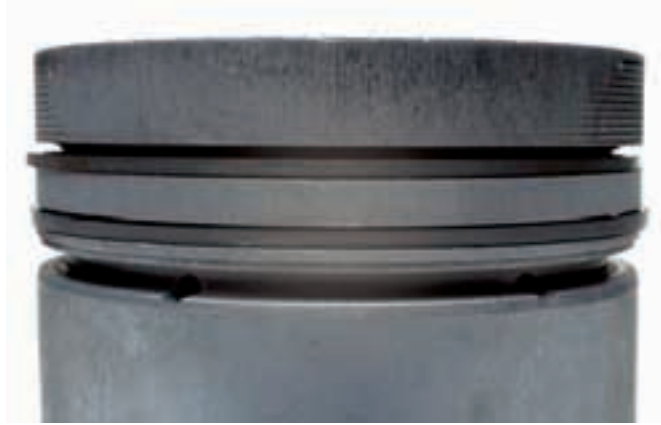
Fig. 4
Axial wear at the piston rings

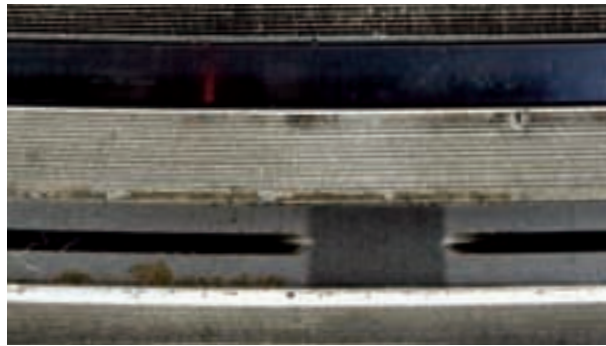
Fig. 5
Heavily worn oil control ring

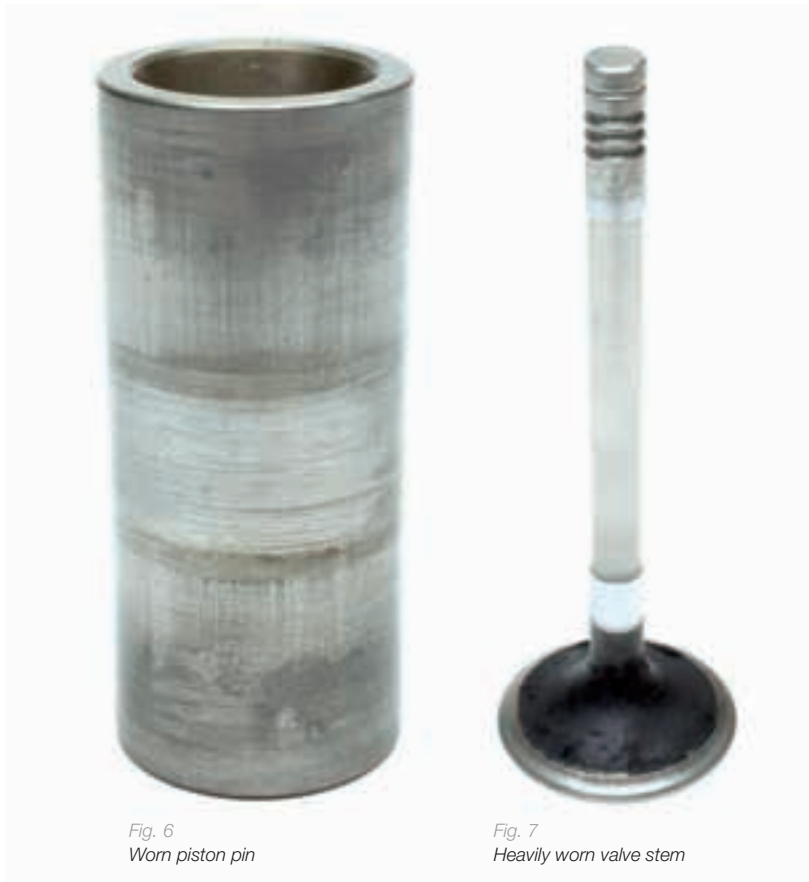
Fig. 6
Worn piston pin

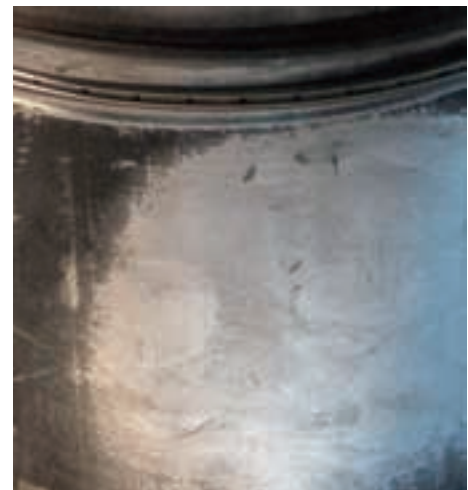
An excessive amount of fuel in the oil dilutes the oil film, thus drastically reducing its load-bearing ability and increasing engine component wear. This type of damage can have the following causes:

- The injection system is set incorrectly.
- Cold start enrichment is too rich.
- The injection nozzles are functioning incorrectly, e.g. due to a clogged fuel filter.
- Due to an excessive protrusion, the piston hammers the cylinder head, causing uncontrolled injection.
- The compression is weak. This can be attributed to the following conditions:
 - A valve is leaky.
 - The cylinder head gasket is leaky.
 - The timing is set incorrectly.
 - The protrusion is too small.
 - One piston ring or several piston rings are defective.
 - An error has occurred in the ignition system, e.g. a defective spark plug.

Fig. 1
Wide wear pattern and scoring marks due to fuel dilution

- Set the injection system correctly (cold start enrichment, etc.).
- Check the injection nozzles.
- Installation dimensions must be observed.
- Always adhere to fuel filter maintenance intervals, and shorten the time between intervals accordingly in extreme conditions.
- Check the spark plugs and, if necessary, replace them.

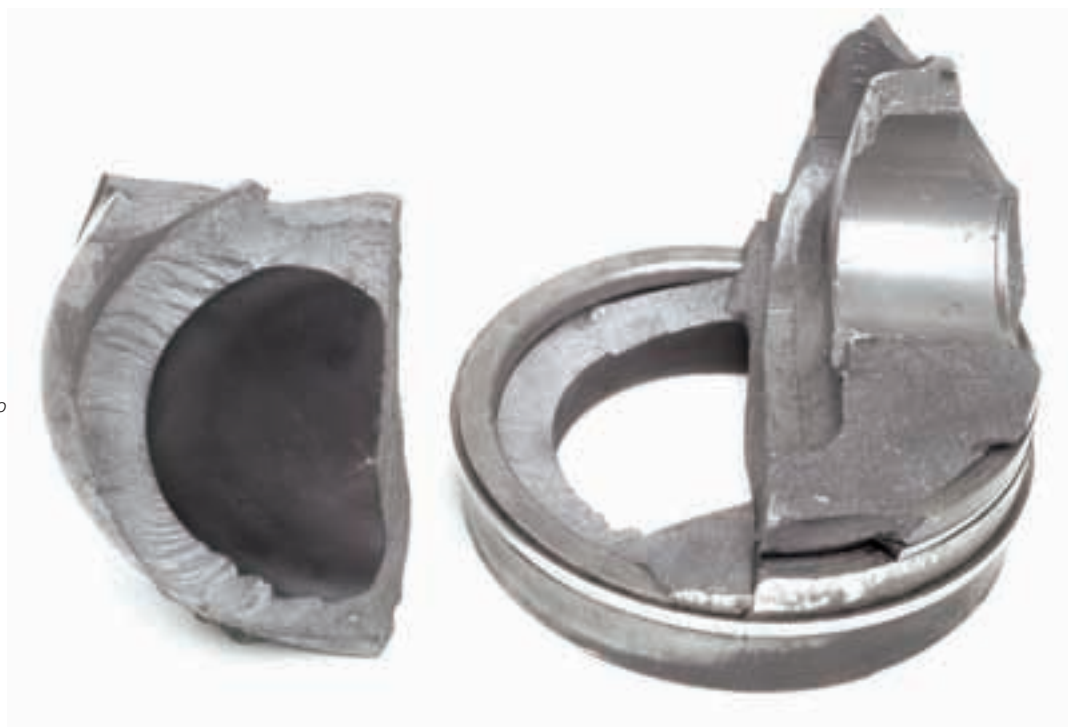
This damage is caused by liquid. Water or fuel reaching the combustion chamber. Since neither water nor fuel can be compressed, hydraulic lock results in an abrupt stress load at the piston, the piston pin, the connecting rod, the cylinder head, the crankcase, the bearing and the crankshaft. Excessive liquid may reach the combustion chamber due to the following reasons:

Fig. 1
Broken commercial
vehicle piston due to
hydraulic lock

- Always use new and undamaged gaskets when overhauling an engine. Defective gaskets must be replaced.
- Always check injection nozzles and, when necessary, renew them.

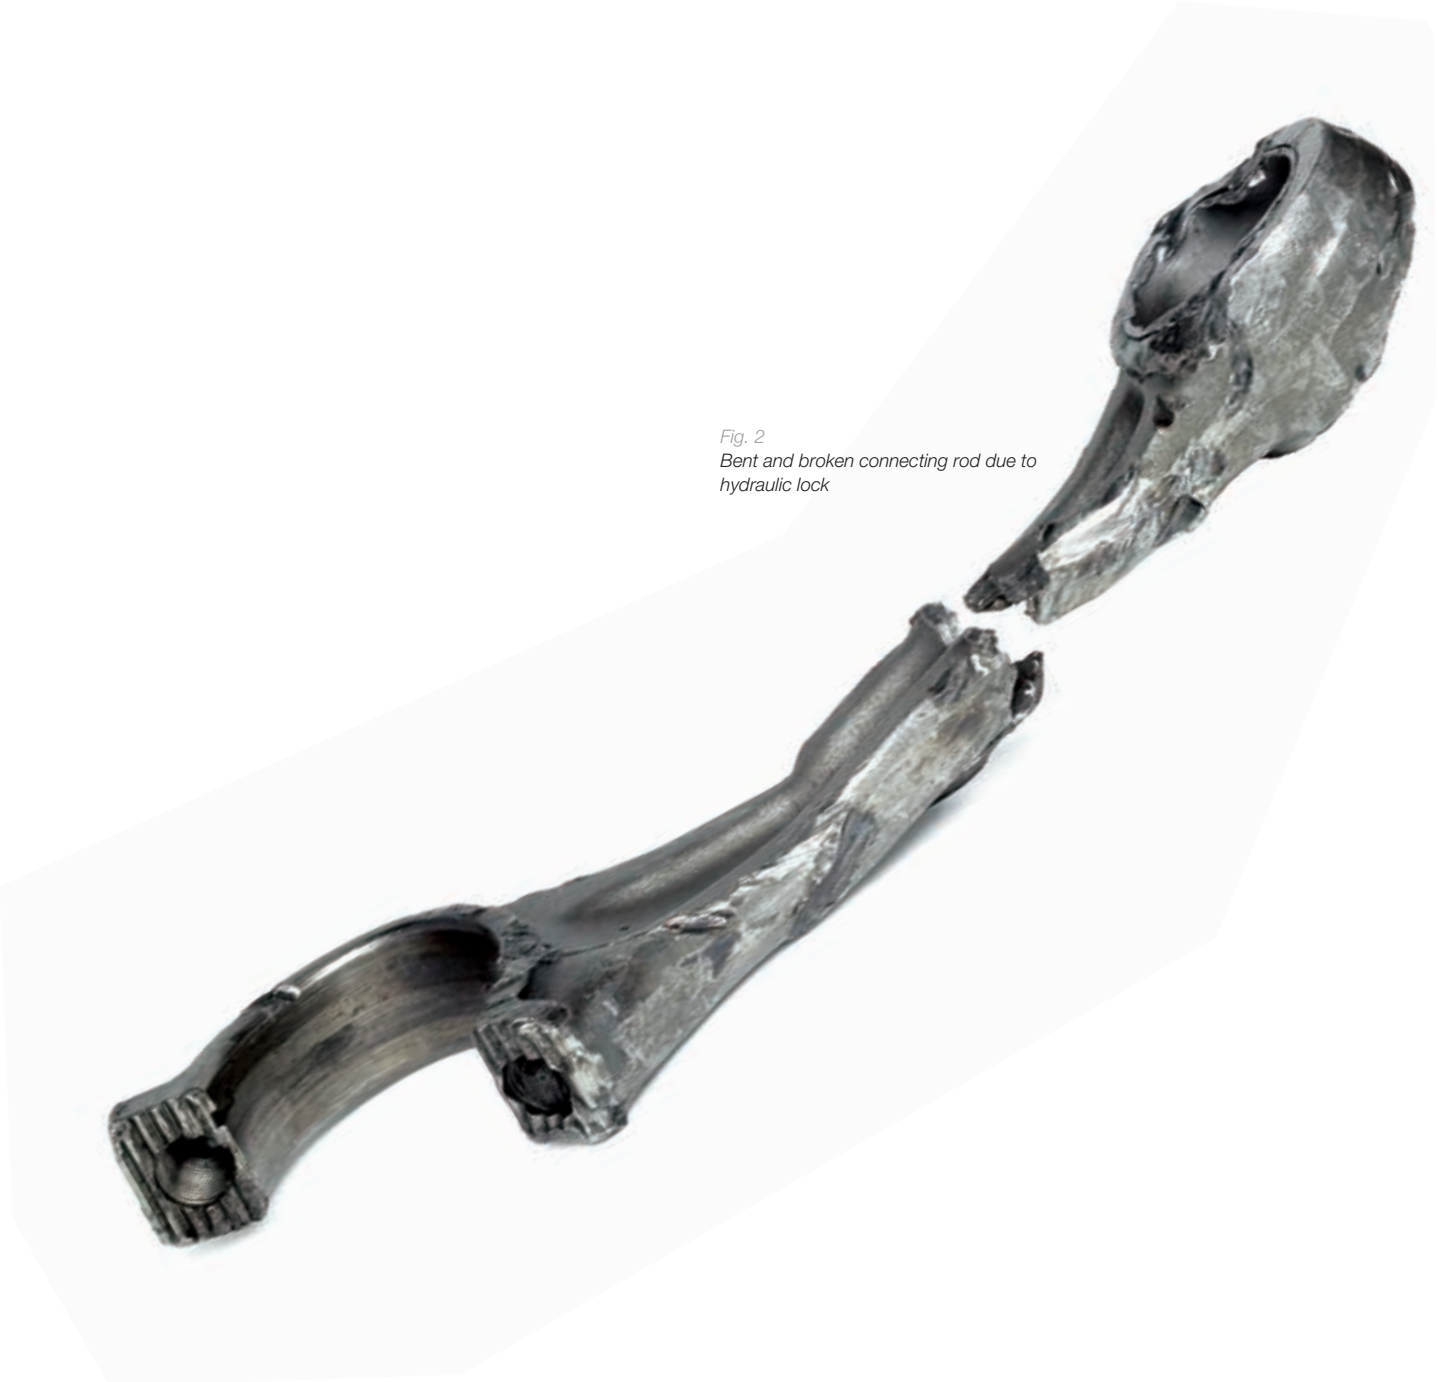
Fig. 2
Bent and broken connecting rod due to hydraulic lock

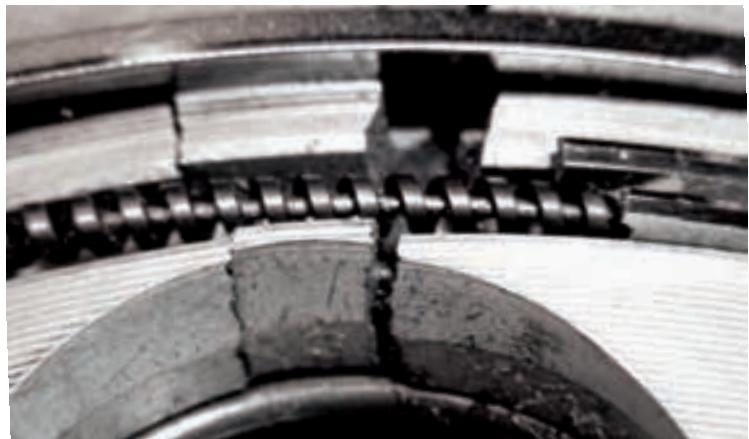
Fig. 3b
Close-up view of an overload fracture

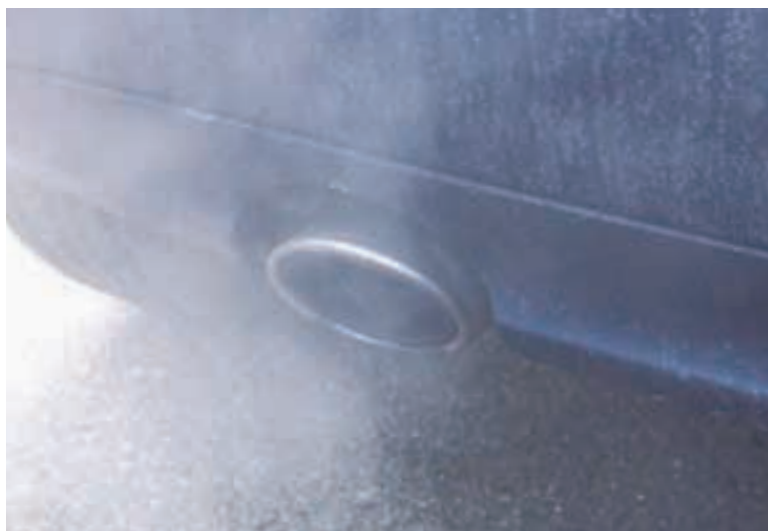
Fig. 2
A smoky exhaust pipe

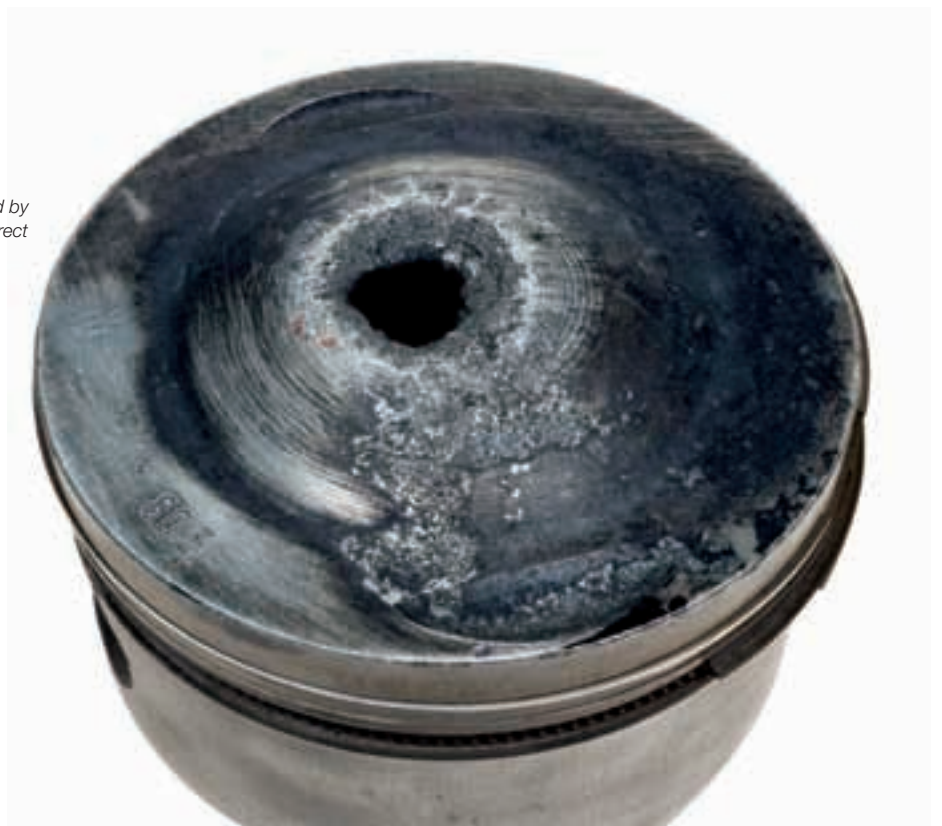
- The heat value of the spark plug is too low.
- Surface ignitions caused by an overheated spark plug have occurred (also see section “3.2 Melting at the top of the piston and the top land in a gasoline engine”, page 16).

Fig. 1
Hole in the top of the piston, caused by the use of spark plugs with an incorrect heat value

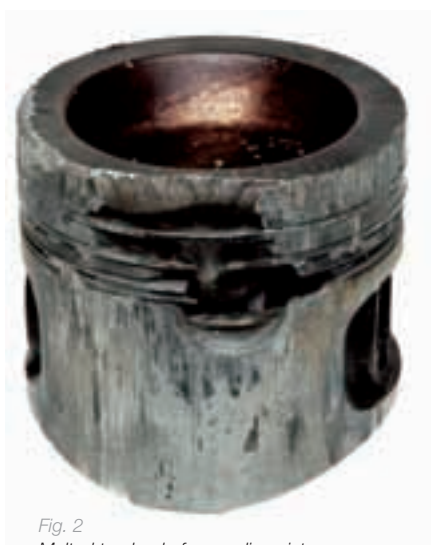
Fig. 2
Melted top land of a gasoline piston

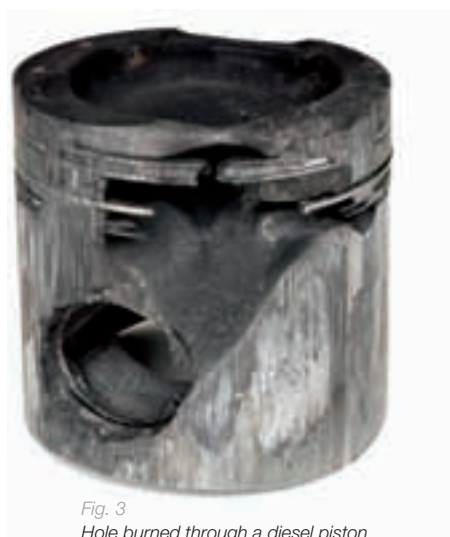
Fig. 3
Hole burned through a diesel piston

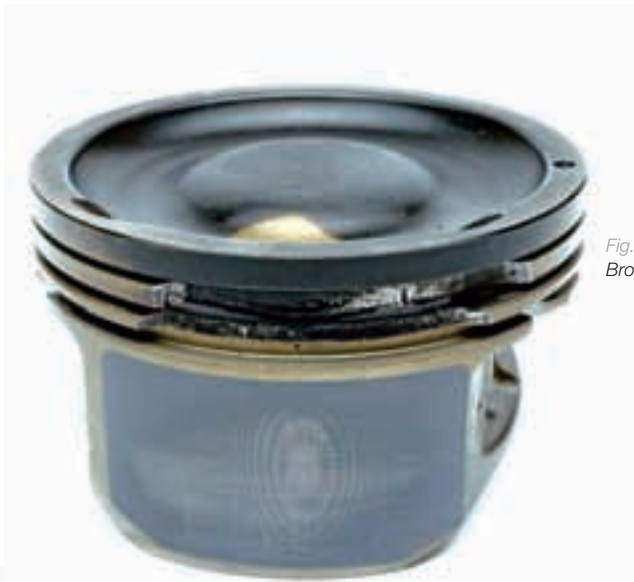
Fig. 2a
Broken piston ring lands

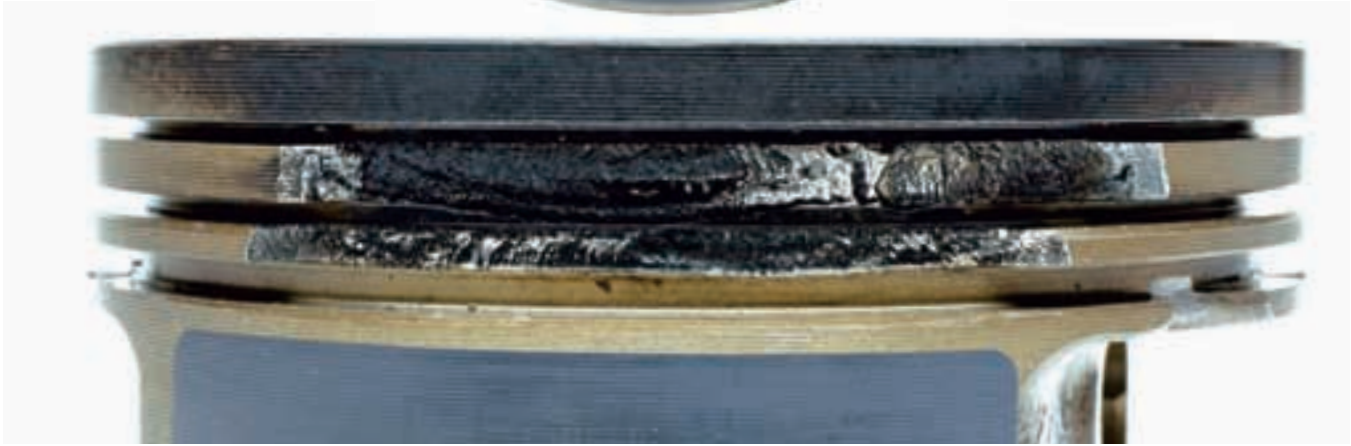
Fig. 2b
Close-up view of the broken piston ring lands

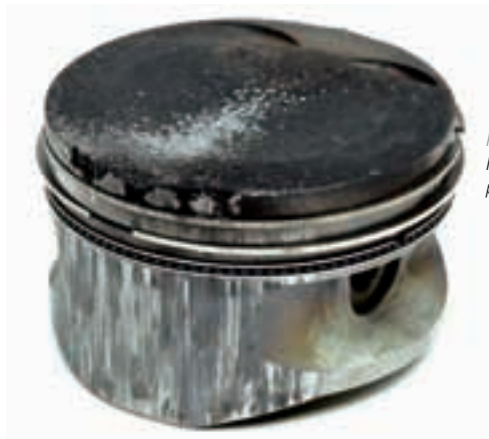
Fig. 3
Heavy erosion and melting at the piston crown

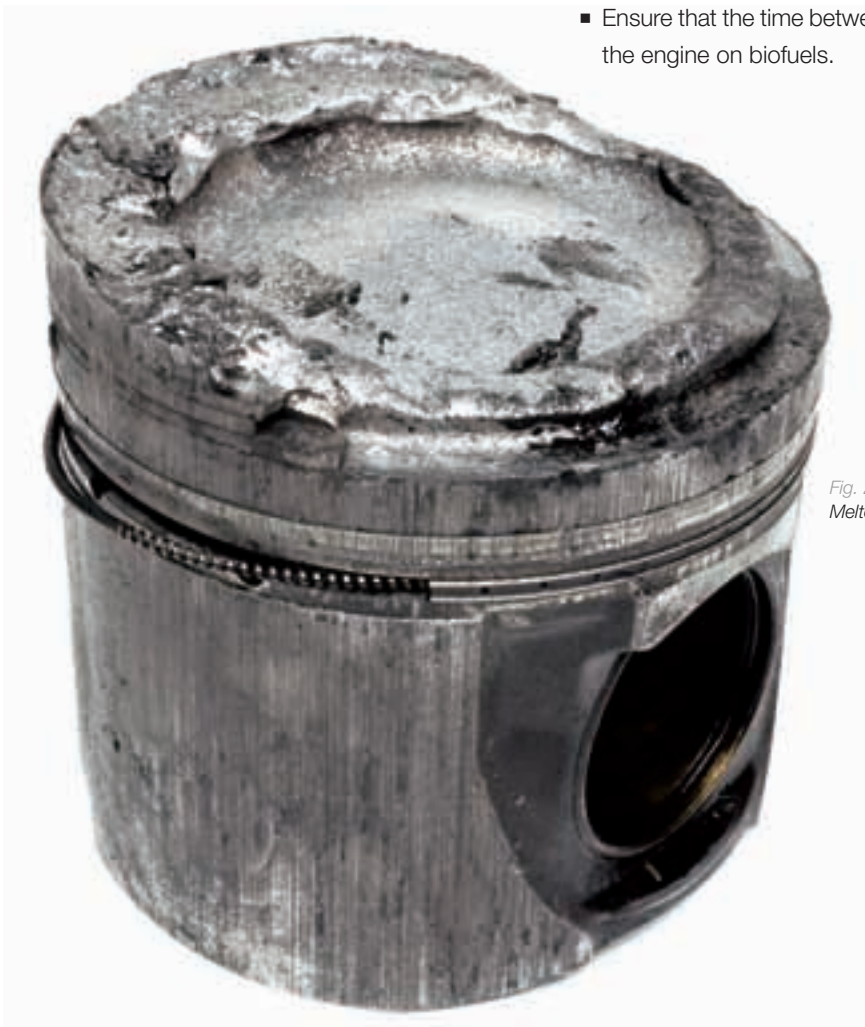
Fig. 2
Melted piston crown at a diesel piston

- Set the injection amount and timing according to the manufacturer's specifications.
- Check the injection nozzles for any leaks, the injection pressure and the spray pattern.
- Pay attention to correct alignment when assembling the cooling oil nozzles.
- Thoroughly clean the oil channels in the engine block, the crankshaft and the cylinder head.
- Make sure the pressure regulating valve is functioning correctly.
- Ensure that the time between oil changes is much shorter when running the engine on biofuels.

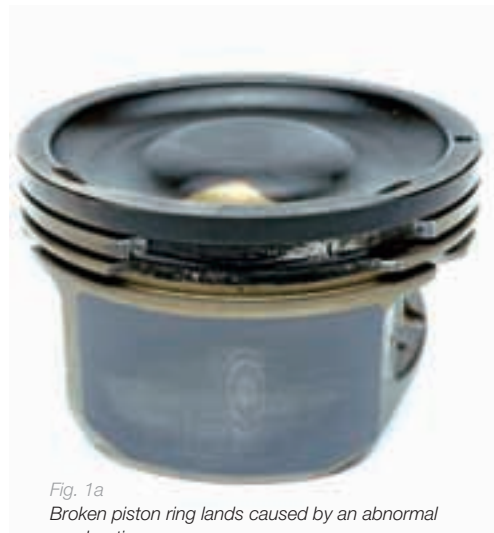
Fig. 1a
Broken piston ring lands caused by an abnormal combustion

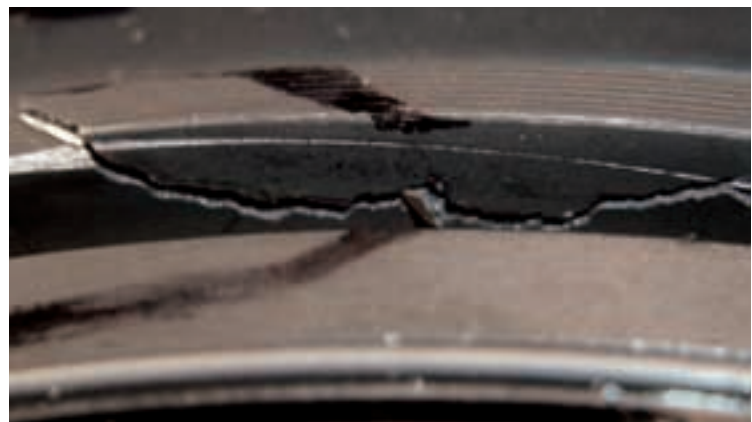
Fig. 3
Assembly error with an imprint of the piston ring

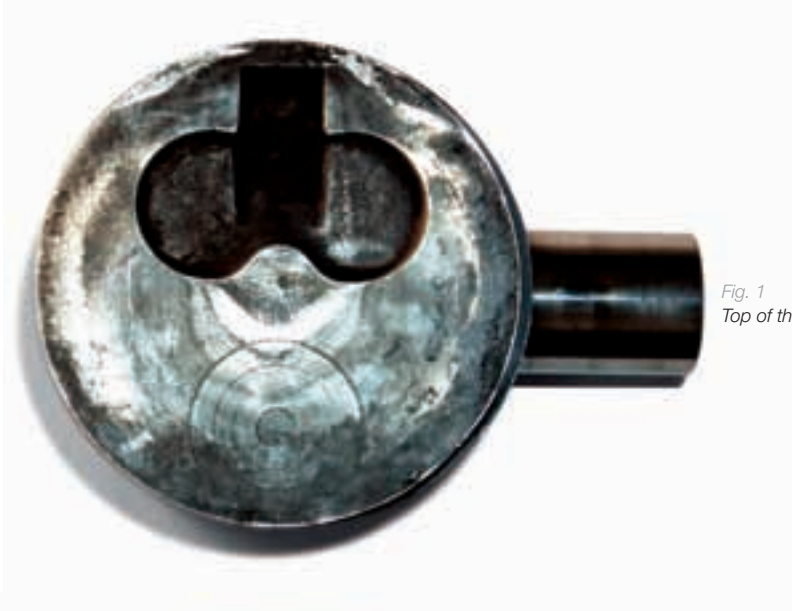
Fig. 1
Top of the piston with valve impact

- Set the timing correctly during installation.
- Check the protrusion at all the cylinders during installation.
- If unusually loud operating noises are audible, switch off the ignition and determine the source of the noise to prevent any consequential damage.

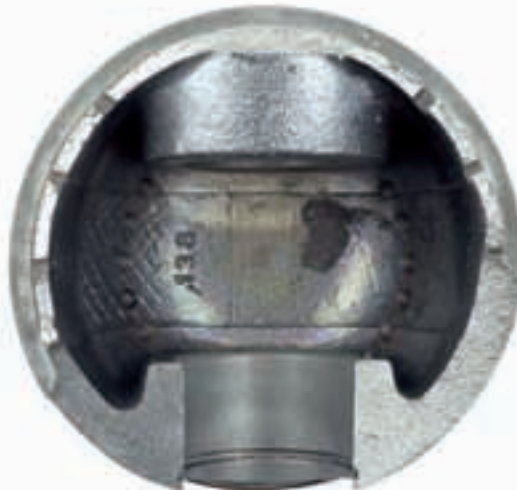
Fig. 3
Piston snapped off at a right angle at the height of the piston pin axis

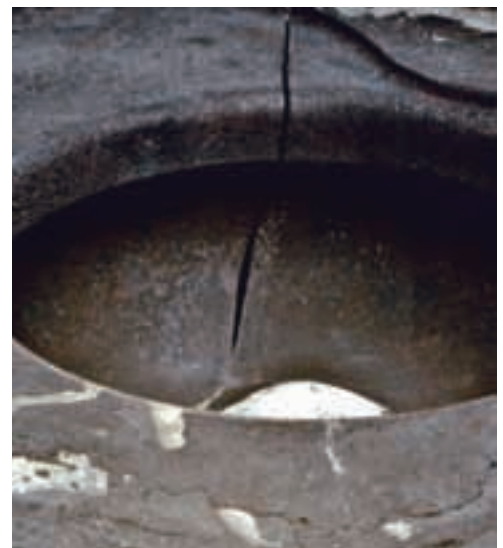
Fig. 1
Cracks in the bowl rim

- Tuning and the required engine modifications should only be carried out by the engine manufacturer or trained and qualified engine tuners.
- Set the injection pump according to the manufacturer’s specifications.

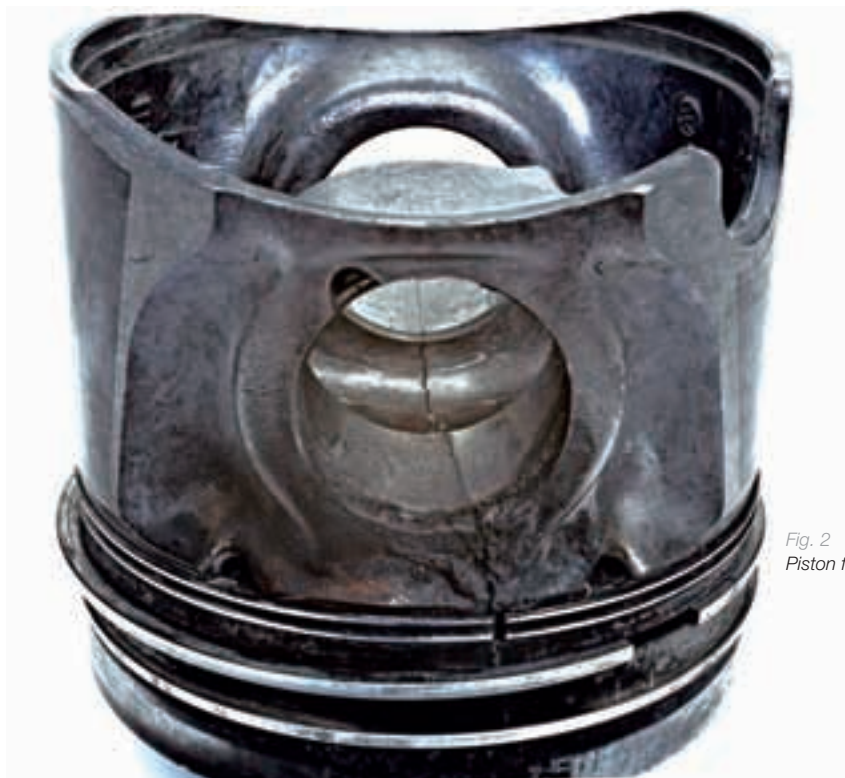
Fig. 2
Piston fractured right into the pin bore

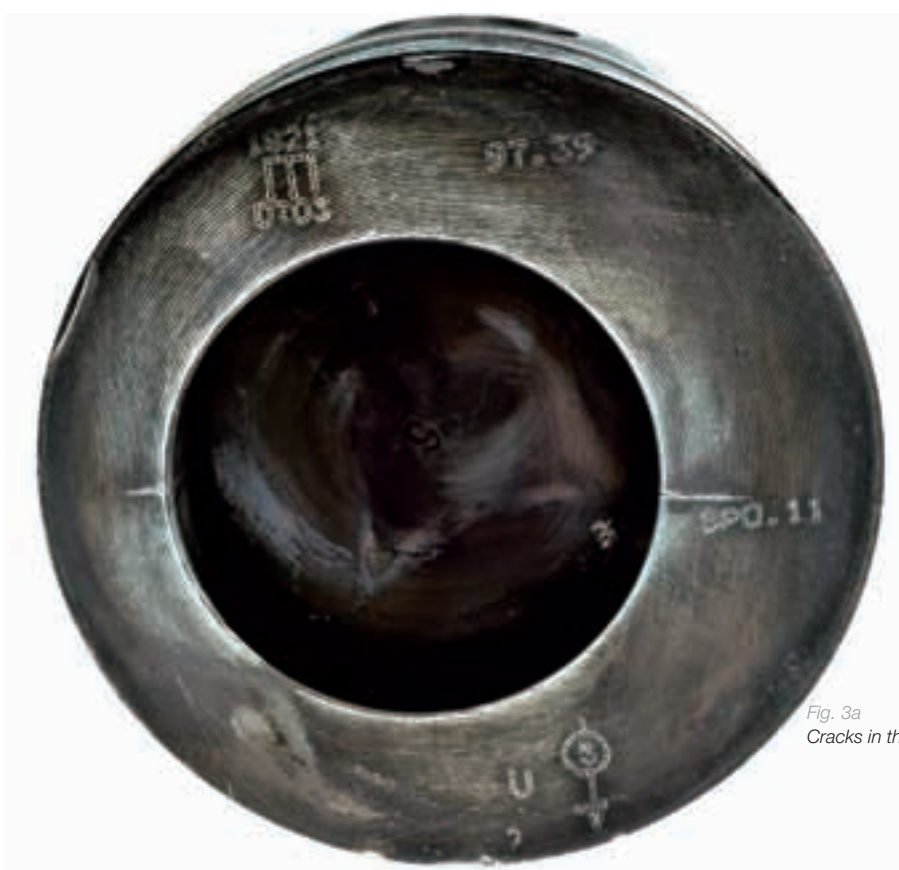
Fig. 3a
Cracks in the bowl rim

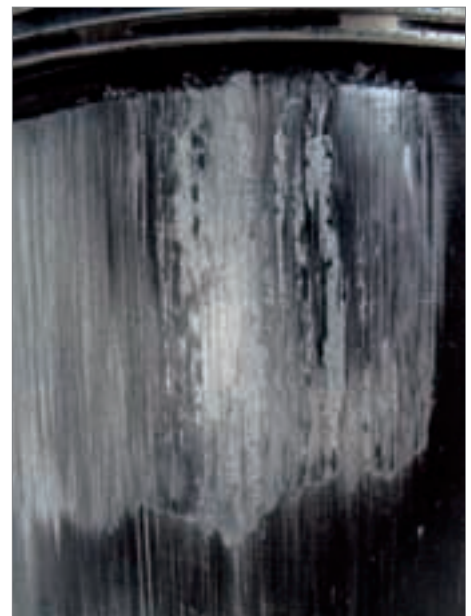
Fig. 2
Partially shiny seizure marks

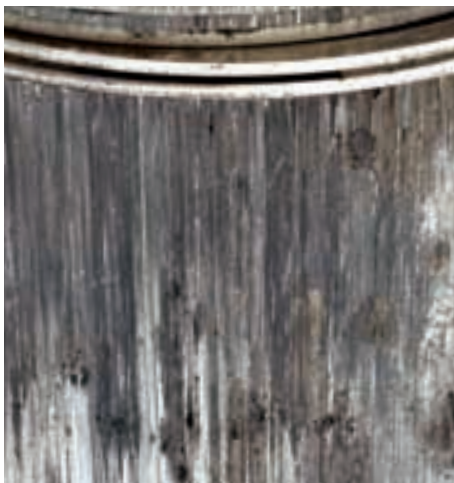
Fig. 1
Seizure only on the thrust side of the piston skirt

- Ensure a correct supply of oil – and check that the oil feeder holes in the connecting rod are not clogged.
- Only use engine oils approved by the engine manufacturer.
- Operate the engine at a moderate speed and load immediately after assembly.
- Regular oil level checks are imperative; if necessary, refill oil.
- Check the oil pressure. Insufficient oil pressure can be caused by a worn oil pump, a dirty filter, a defective pressure relief valve in the oil pump or diluted oil.
- Check the cooling system.

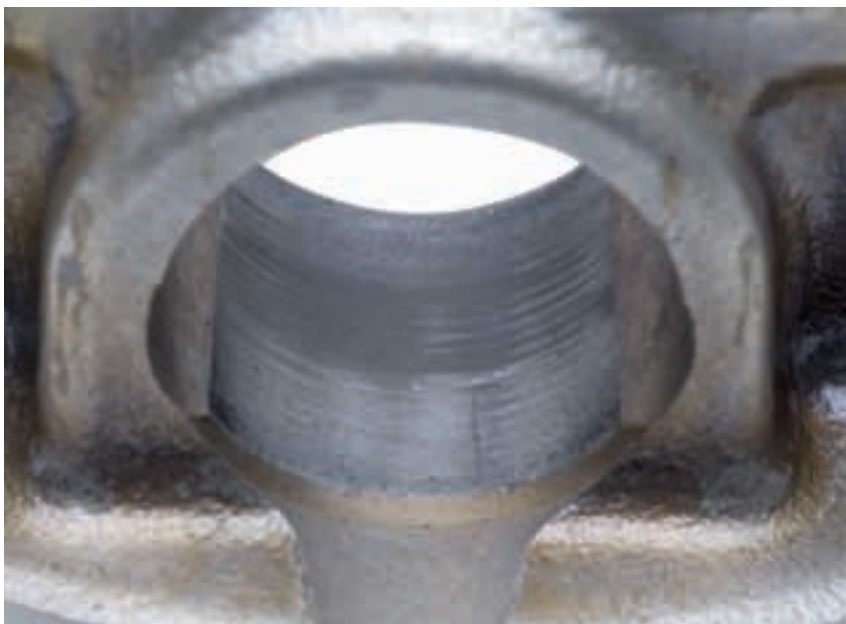
Fig. 3
Pin bore with seizure marks

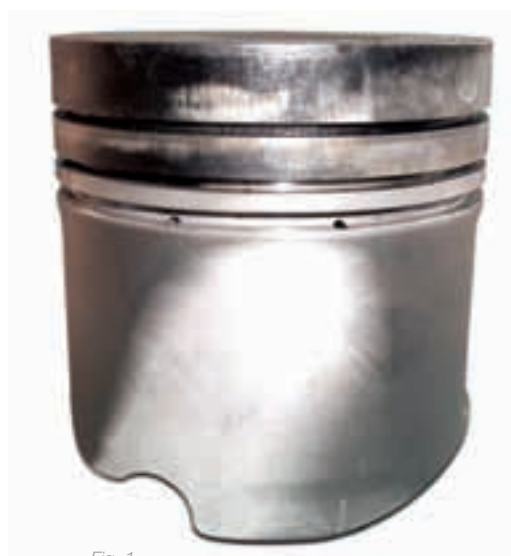
Fig. 1
Asymmetrical wear pattern (slanted position)
at the piston skirt

- Align the main bearing line, the crankshaft and the connecting rod properly during machining and installation (concentricity).
- Make sure that the connecting rod is aligned correctly.
- Tighten the cylinder head bolts according to the manufacturer’s specifications.
- Always pay great attention to cleanliness during engine assembly, e.g. gasket residue must be cleaned up immediately.

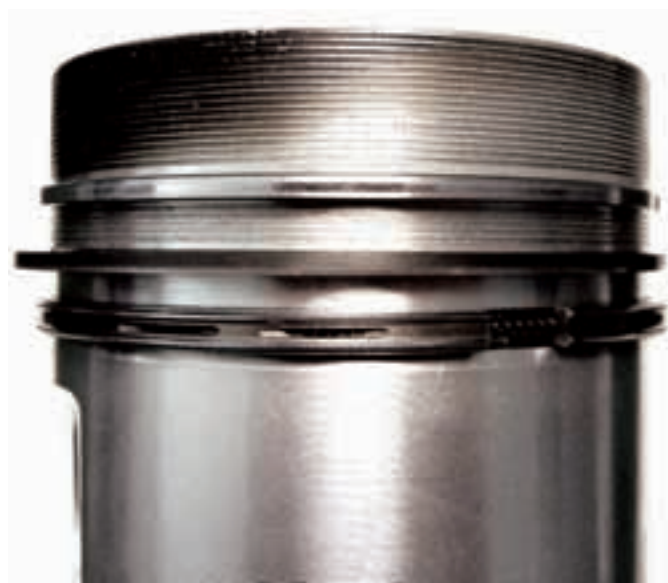
Fig. 2
Top land with irregular
deposits

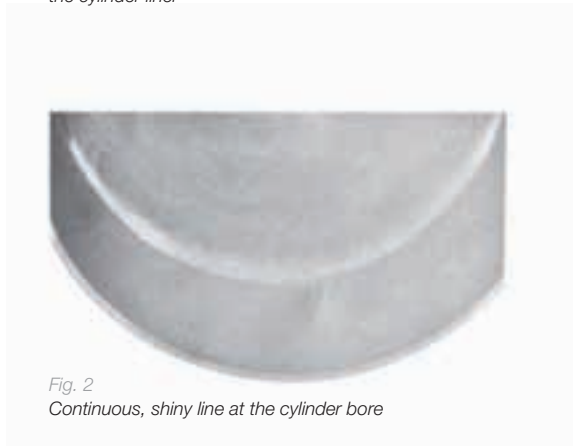
Fig. 2
Continuous, shiny line at the cylinder bore

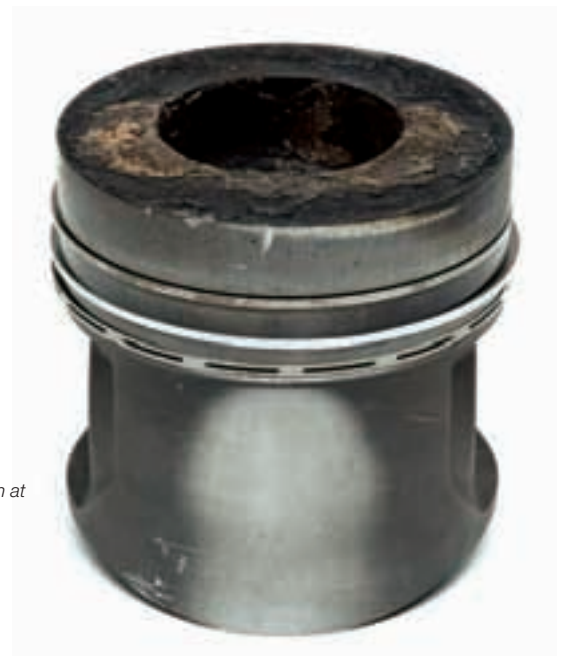
Fig. 1
Wear caused by contamination at the piston skirt

- Check the intake system for leaks.
- Check the air filter and, if necessary, replace it.
- Clean the crankcase and the intake manifolds prior to assembly.
- Always pay attention to cleanliness during assembly.

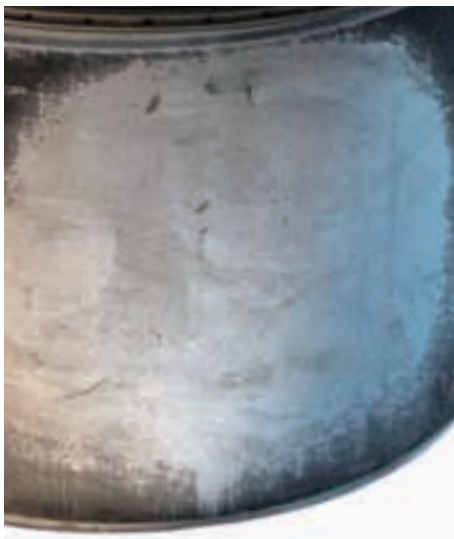
Fig. 1
Wide, shiny wear pattern
and scoring marks

- Set the injection system correctly (cold start enrichment, etc.).
- Check the injection nozzles.
- Always observe installation dimensions.
- Always adhere to fuel filter maintenance intervals, and shorten intervals accordingly in extreme conditions.
- Check the spark plugs and, if necessary, replace them.

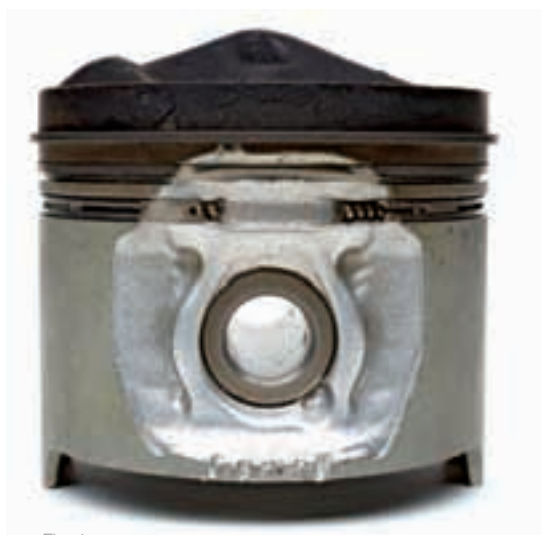
Fig. 1a
Cratered piston wall, caused by a loose piston pin circlip or contamination in the piston pin

- When installing the circlips, ensure that the circlip ends face "6 o'clock" or "12 o'clock".
- Always fit new, perfectly shaped circlips.
- Never use force to insert the piston pin, e.g. with a hammer.
- Make sure the bores are parallel before assembling the connecting rod.

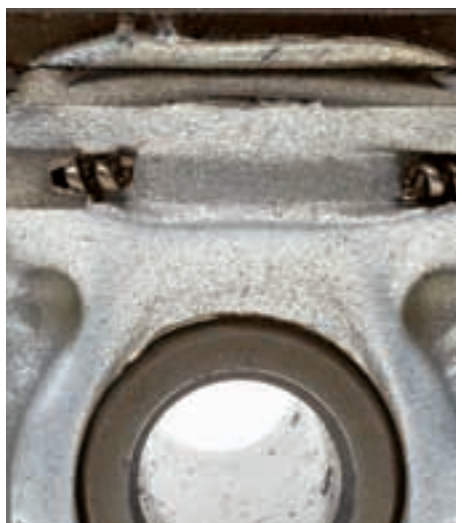
Fig. 1b
Close-up surface view of softer piston material and harder piston ring material worn to the same extent

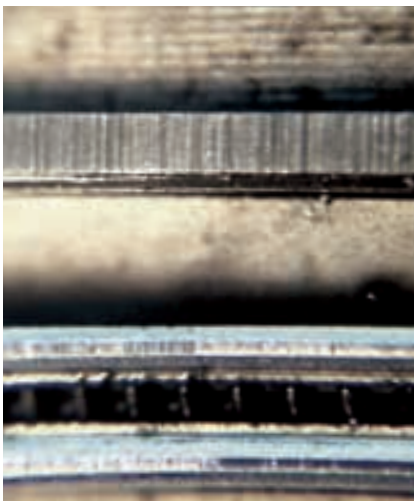
Fig. 1
Piston rings with scoring marks and burn marks

Avoid high speeds or high loads at low speeds (RPM's) during the break-in phase.

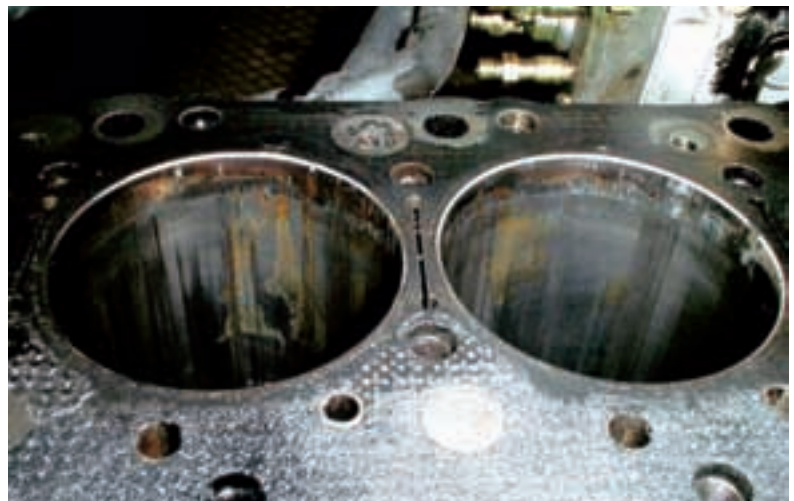
Fig. 2
Cylinder bore with longitudinal scoring marks

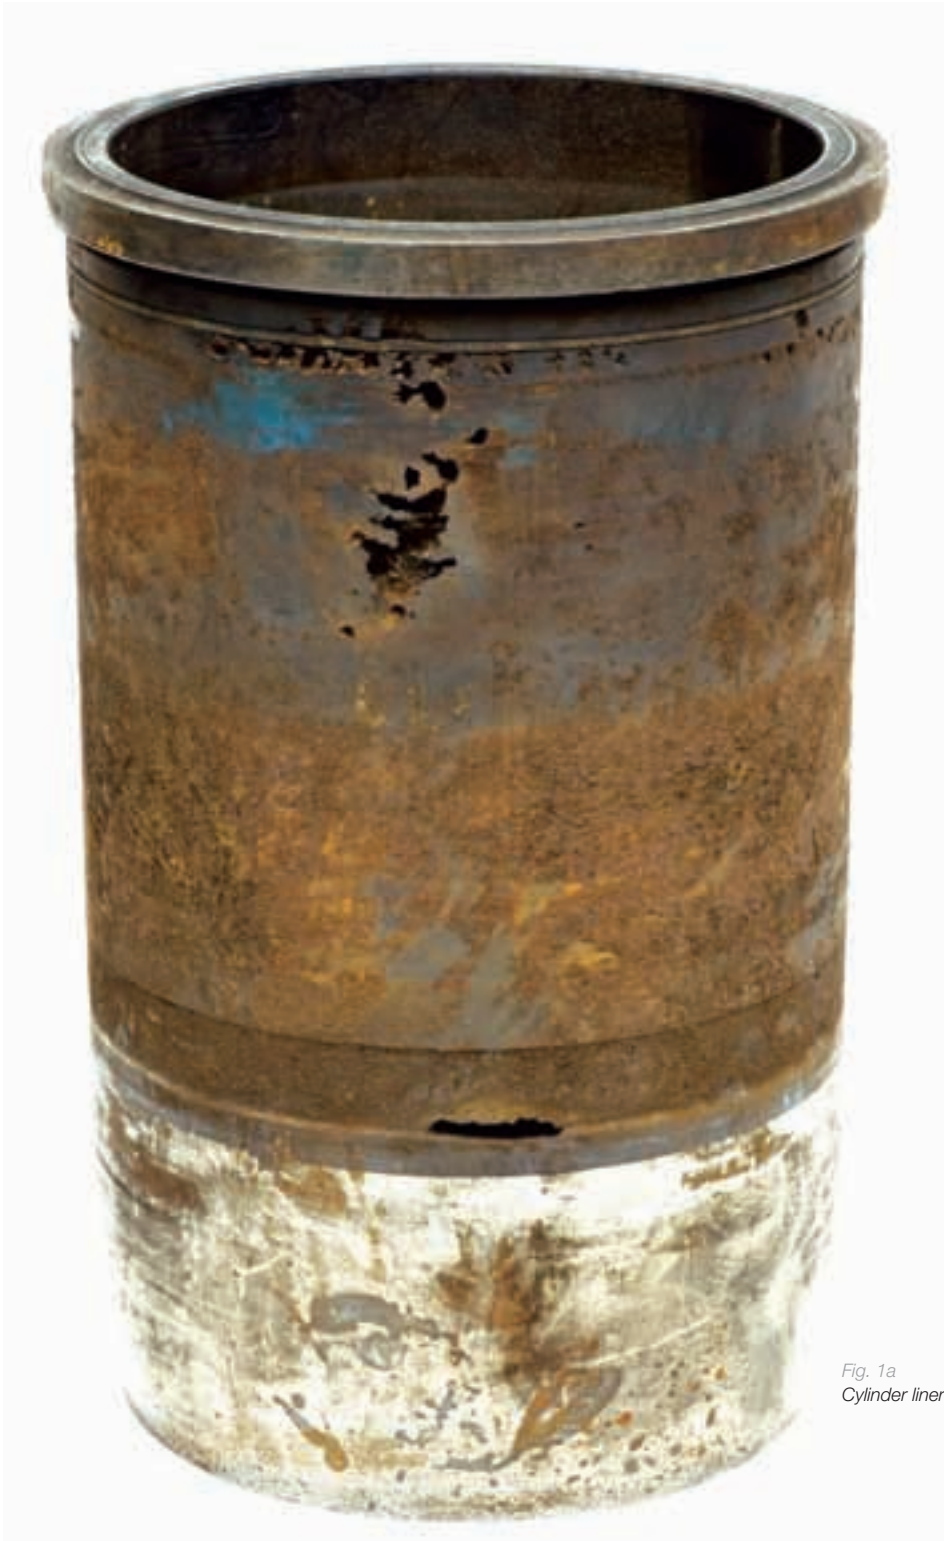
Fig. 1a
Cylinder liner with cavitation damage

- Always check the cooling system (radiator cap, hoses, clamps) for leaks.
- Ensure there is sufficient anti-freeze with corrosion protection.
- Make sure the cooling system is functioning correctly (thermostat, fan, thermo switch).

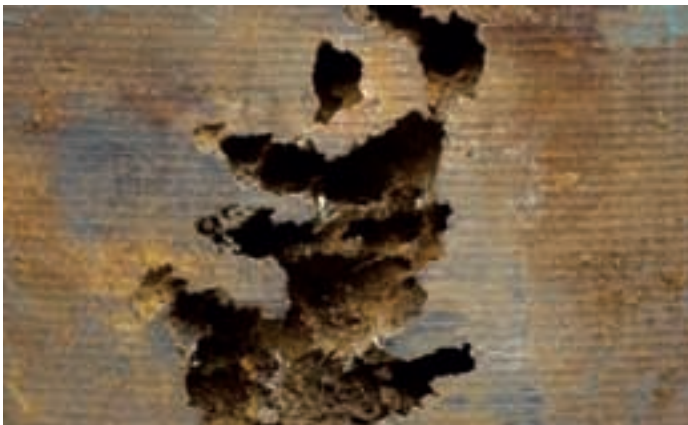
Fig. 1b
Close-up view of the cylinder liner with sharp edges and cavities which become larger towards the inside

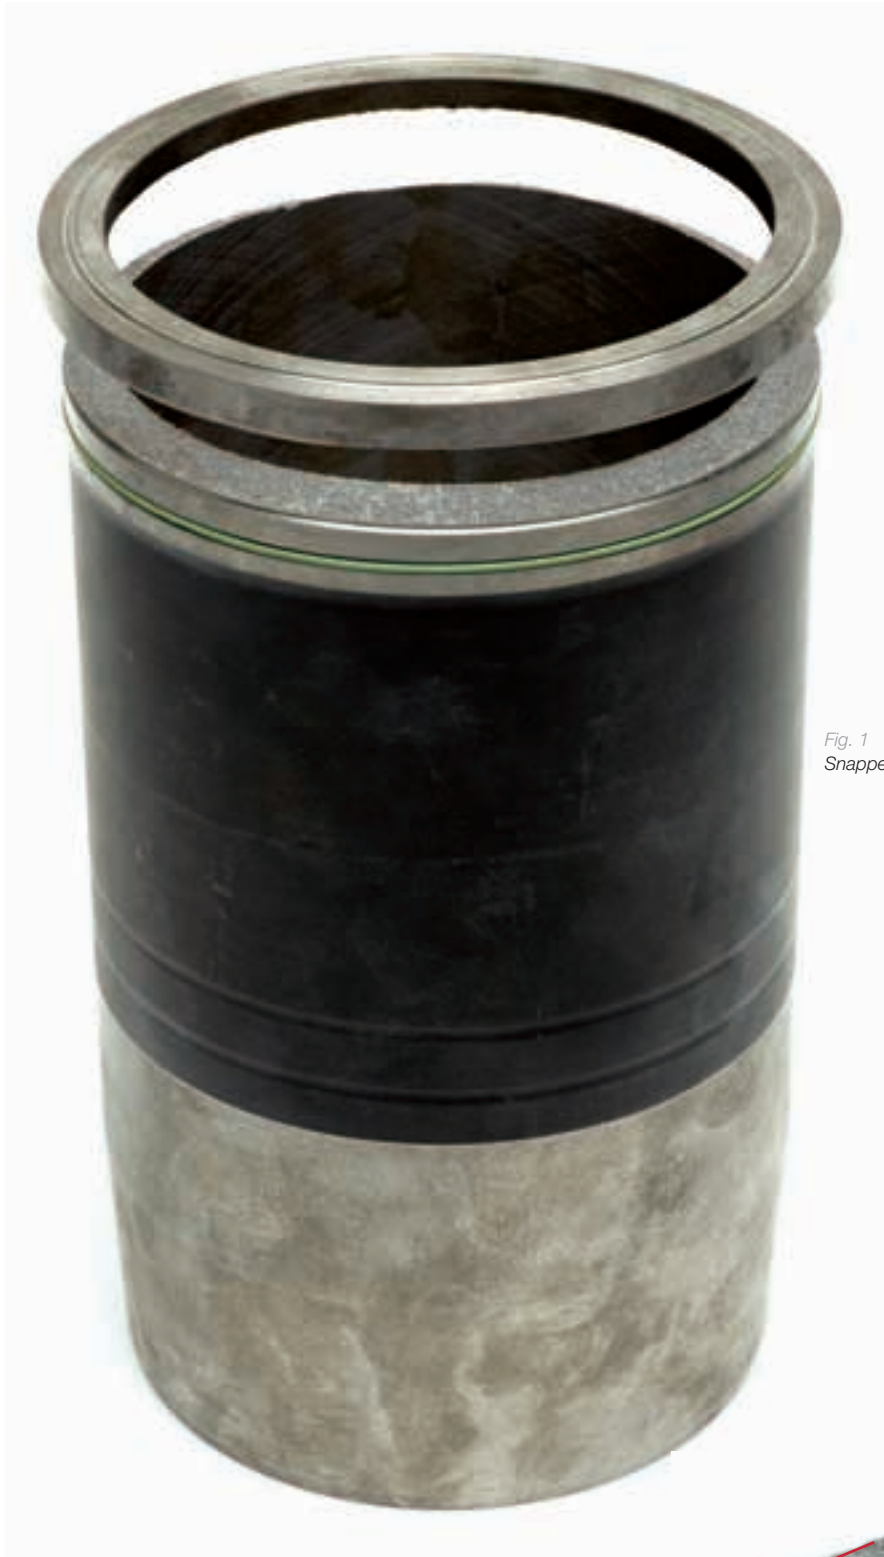
Fig. 1
Snapped off cylinder liner flange

- Always ensure precise machining of the flange seat in the engine block.
- Make sure that the cylinder liner seat is plane and rectangular.
- After machining, the sharp-edged seat surface must be chamfered.
- Only use the cylinder head gaskets recommended for the engine.

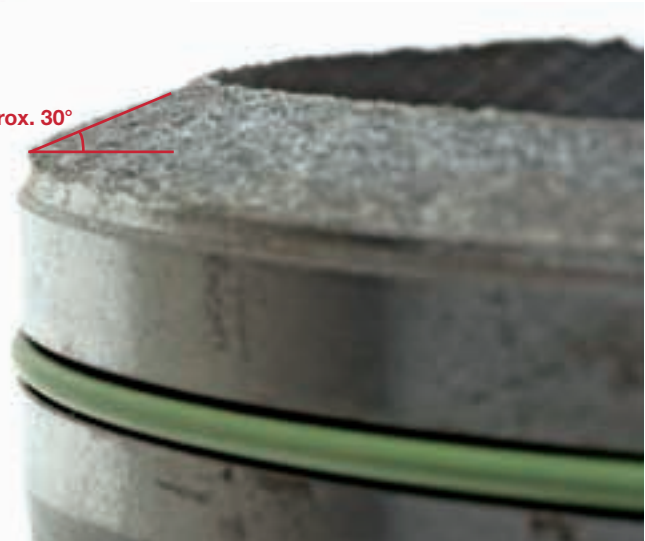
Fig. 2
Fracture with a coarse structure at
an angle of approx. 30°

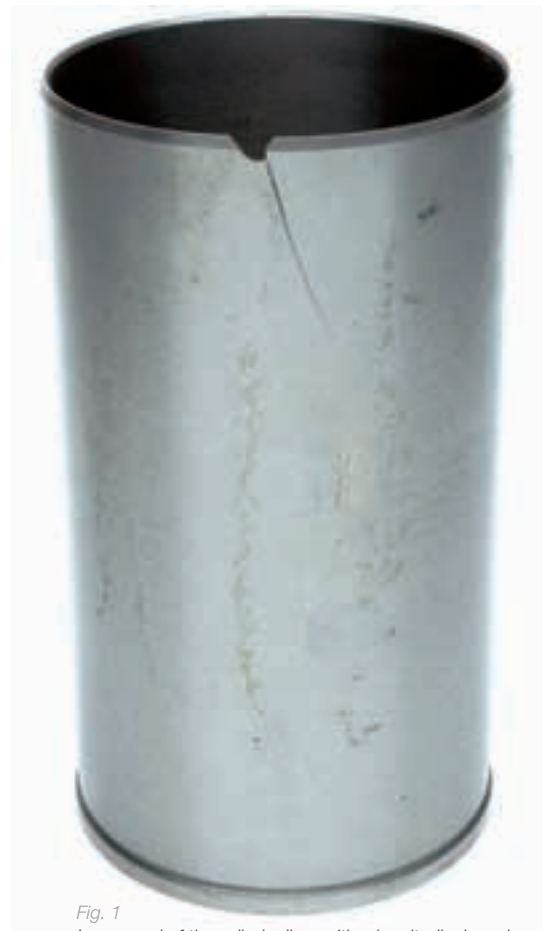
Fig. 1
Lower end of the cylinder liner with a longitudinal crack

- Cylinder liners must be transported carefully and only in an upright position.
- Always carry out a ring test before installing the cylinder liner. Also carry out a visible inspection of the cylinder liner surface.

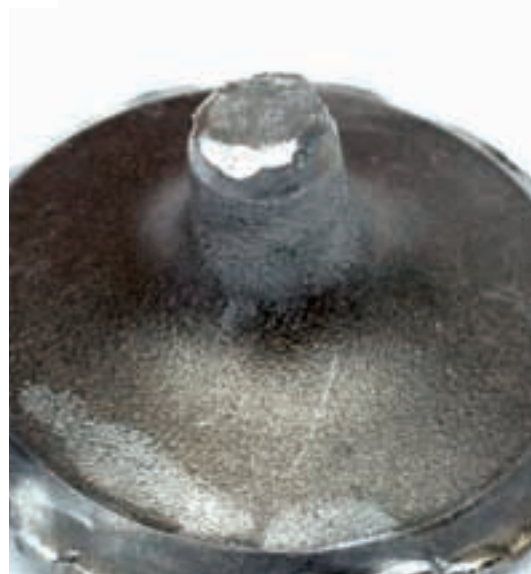
Fig. 3
Vibration fracture with fracture surface at the valve stem

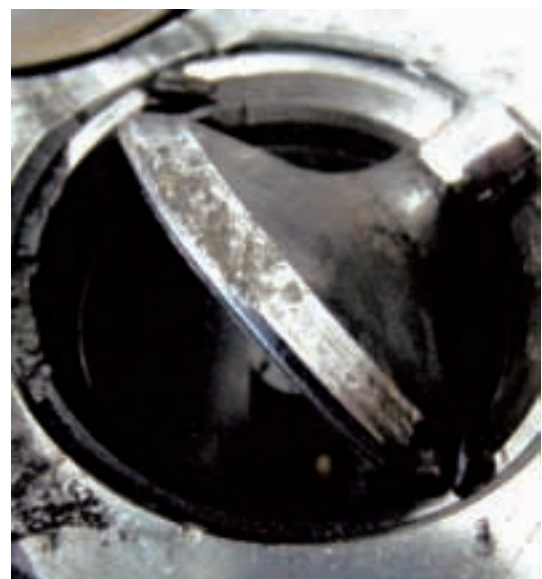
Fig. 1
Snapped off valve in the valve head area

- Set the timing correctly during assembly.
- Always check the valve depth carefully during cylinder head repair work.
- Avoid over-speeding.
- If valves are reused, always check their dimensional accuracy.
- Machine the valve seat carefully, ensuring the valve guide and the valve seat are aligned correctly.

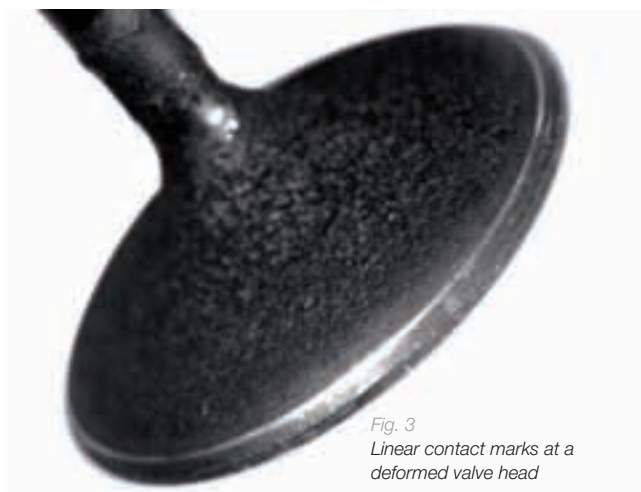
Fig. 3
Linear contact marks at a deformed valve head
