ENGINE COMPONENTS AND FILTERS: DAMAGE PROFILES, PROBABLE CAUSES AND PREVENTION

Technical Information

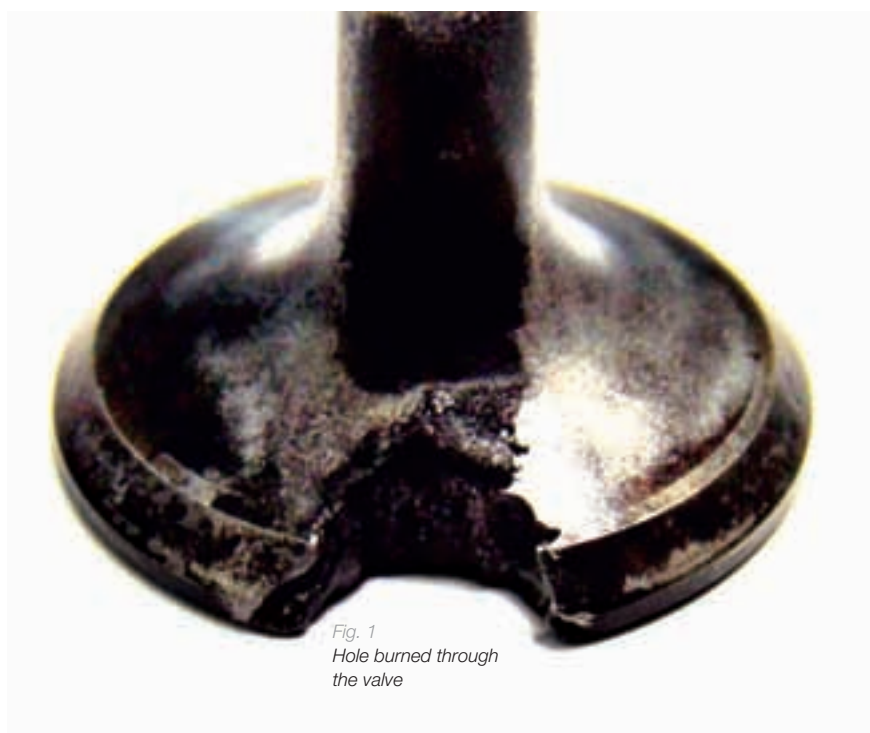
Fig. 1
Hole burned through
the valve

- When re-machining the valve seat, always ensure concentricity between the valve guide and the valve seat.
- Always use new valve keepers. Old valve keepers are usually worn unevenly so that the valves cannot rotate freely.
- Ream the valve guide to the specified dimension using a reamer.

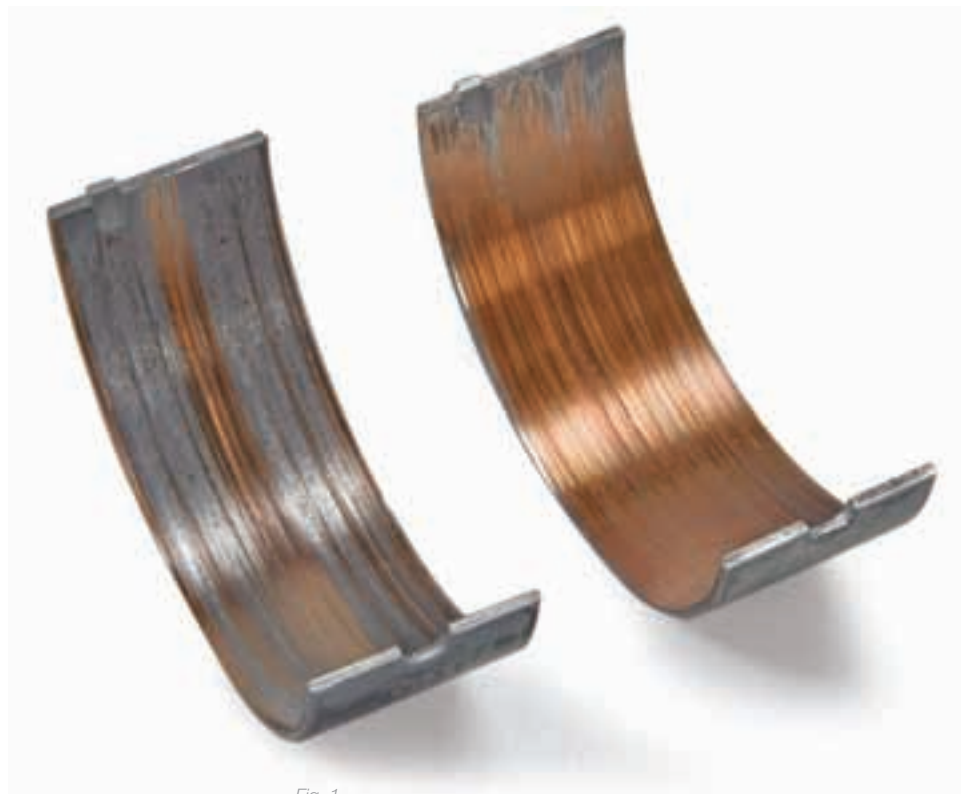
Fig. 1
Heavy scoring in circumferential direction

- Pay great attention to cleanliness when repairing or assembling the engine.
- Only use top quality filters.
- Clean and/or renew the oil mist separator.
- Carry out maintenance at regular intervals according to the manufacturer's specifications.

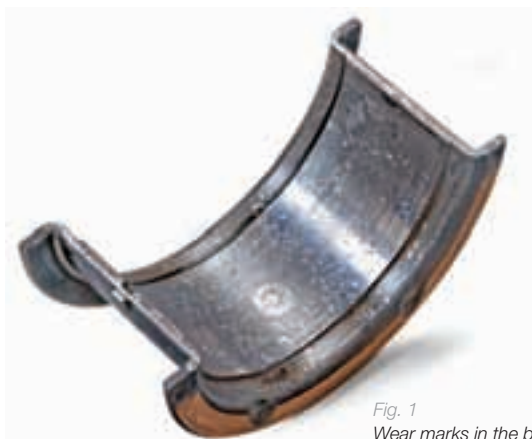
Fig. 1
Wear marks in the bearing center

- Pay great attention to cleanliness during bearing assembly. Clean the bearings with a leather cloth prior to installation.
- Carefully debur the oil holes after machining the crankshaft pins.

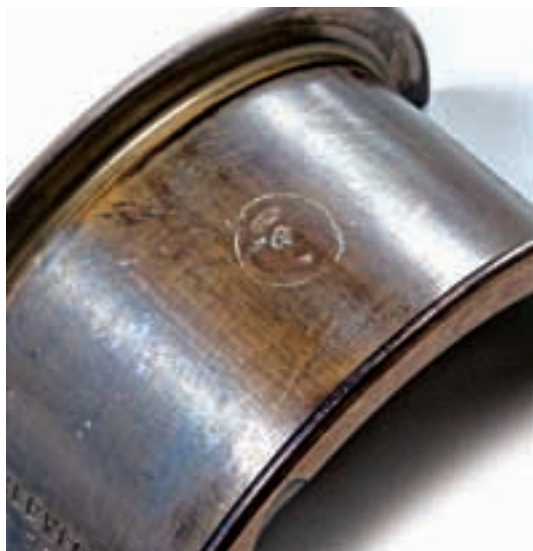
Fig. 2
Contamination imprint on the outer surface of the bearing

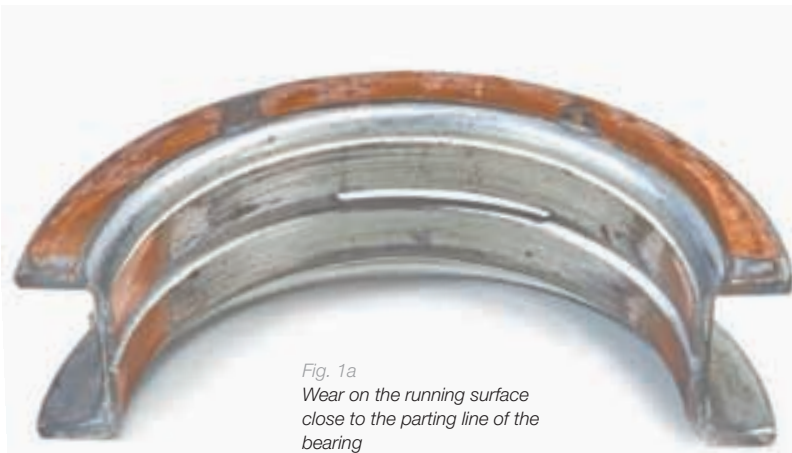
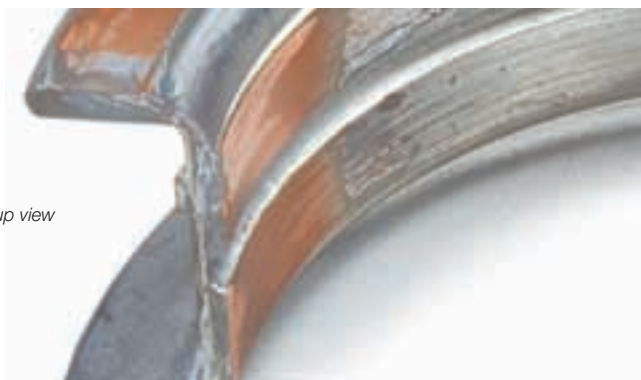
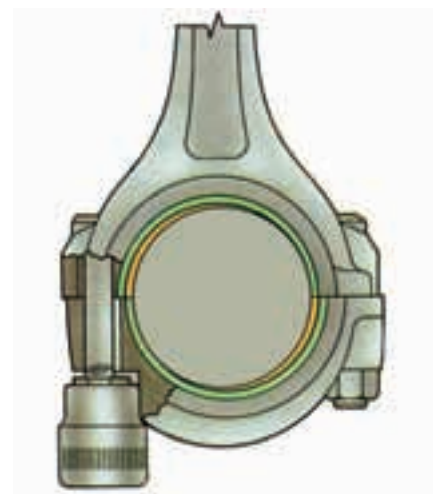
Fig. 2
Offset bearing cap

- Only tighten bolts with a suitable tool.
- Observe the tightening torques of the bearing bolts.
- Pay attention to the allocation of bearing caps and cylinder.
- Check the 'big end' housing and possibly re-machine it.

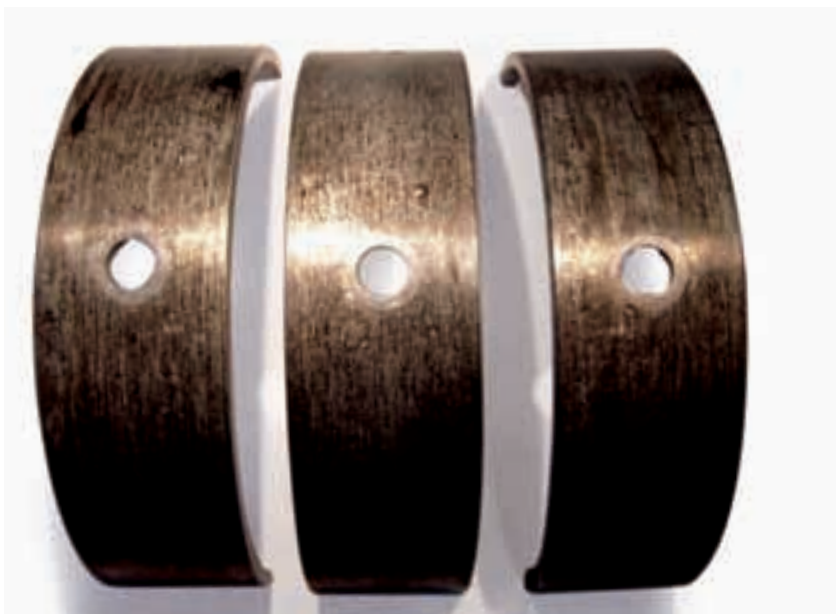
Fig. 1
Shiny marks on the outer surface of the bearing

- Pay great attention to cleanliness during bearing assembly. Clean the bearings and the parting line of the bearing seat with a leather cloth prior to installation.
- Check the bolts of the bearing cap according to the manufacturer's specifications and, if necessary, renew them.
- Tighten the bolts of the bearing cap according to the manufacturer's specifications (tightening torque, angle of rotation).

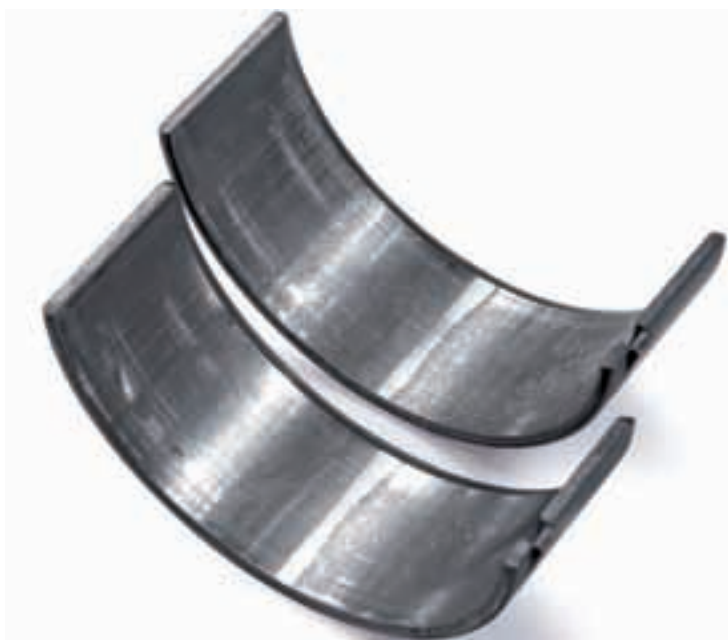
Fig. 1
Worn outer edges of a bearing

- Re-machine the bearing pins to the dimension stipulated by the manufacturer.
- Pay attention to the correct position of the bearings during installation.

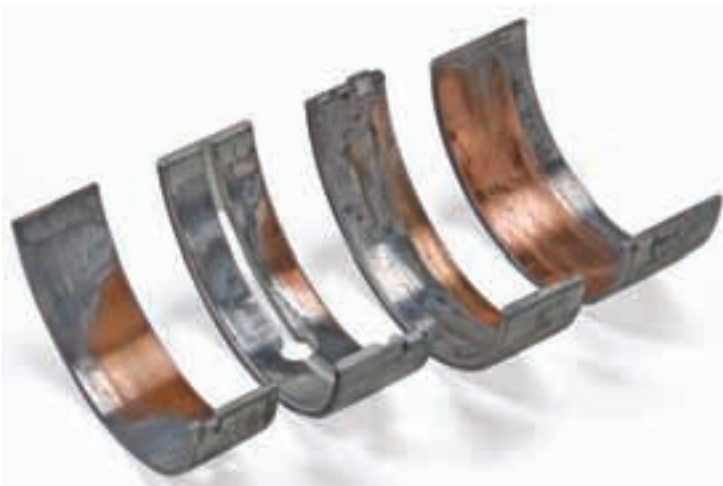
Fig. 1
Uneven wear at the bearings

- Ensure that the engine is cooled sufficiently (coolant, oil, cooling oil nozzles, thermostat, fan).
- Tighten all the bolts according to the manufacturer's specifications. Pay attention to the specified tightening sequence.
- Align the crankshaft perfectly or replace it prior to installation.

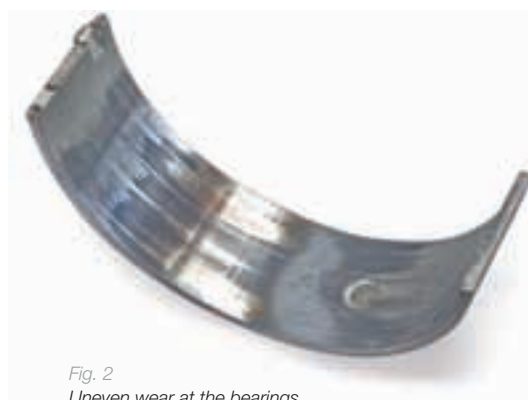
Fig. 2
Uneven wear at the bearings

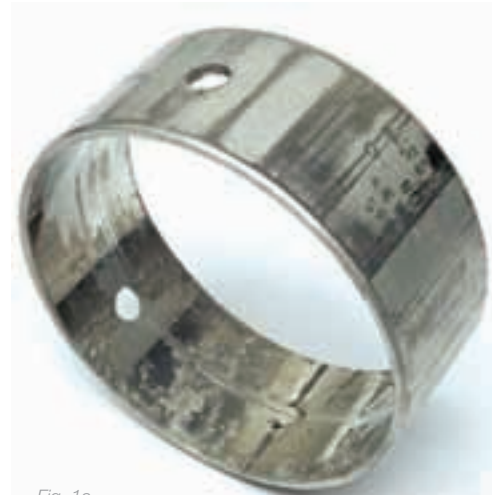
Fig. 1a
Pitting caused by mechanical overload or inadequate load-bearing ability of the oil film

- Only use engine oils approved by the engine manufacturer.
- Always check the correct angle of the connecting rods prior to installation and, if necessary, align them.
- Cylindrically grind the crankshaft pins.

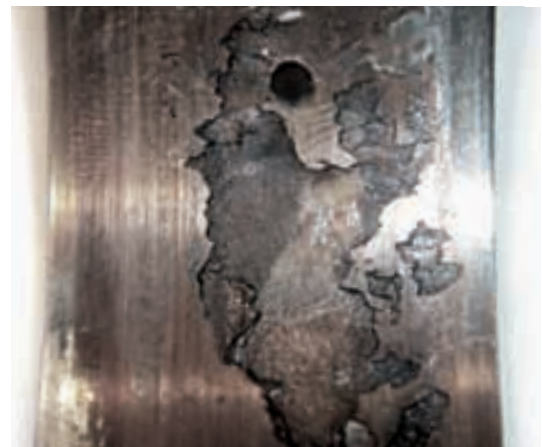
Fig. 1b
Close-up view of the damaged bearing layer

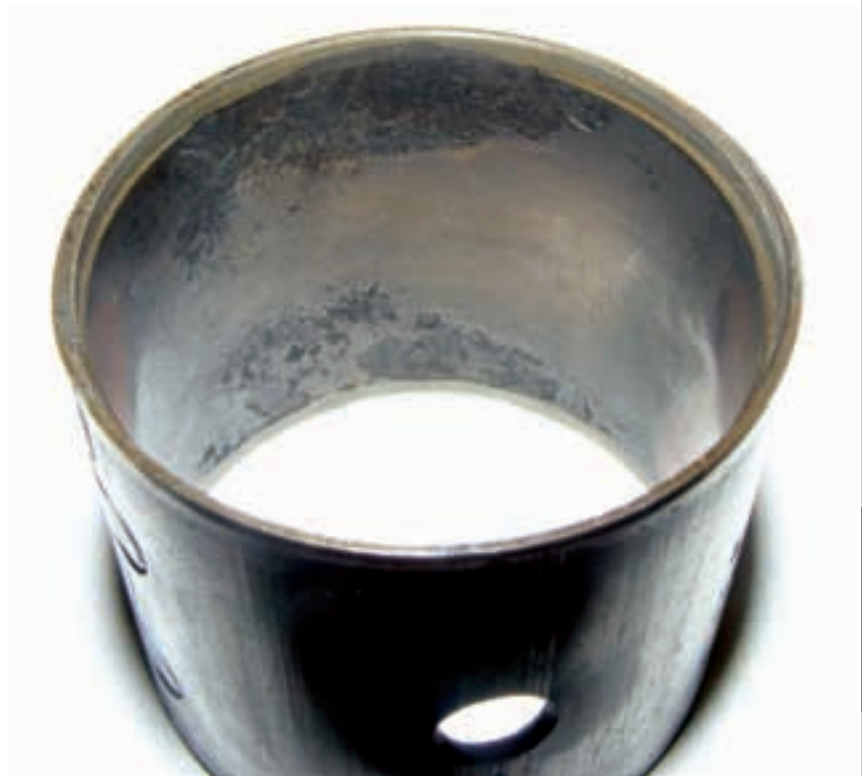
Fig. 2
Damaged connecting rod bushing

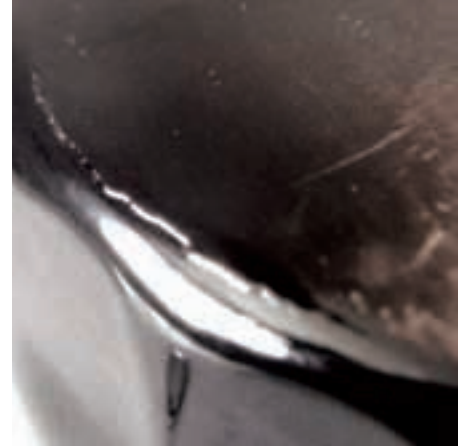
Fig. 1
Crack in the filter housing due to overload caused by pressure fluctuations

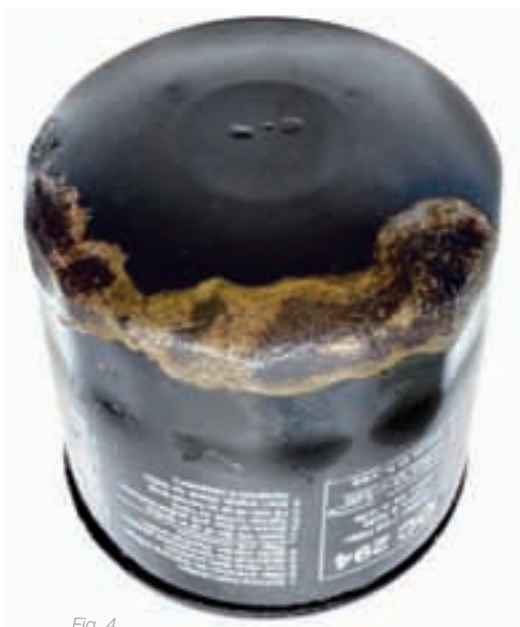
Fig. 4
Damaged coating – the result: Corrosion

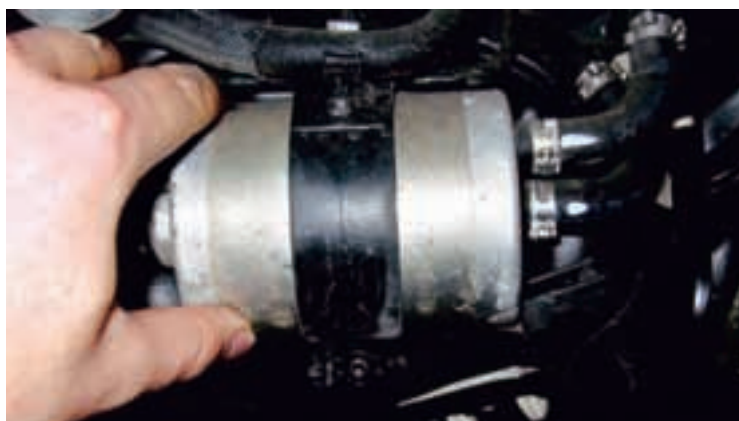
Fig. 6
Contact corrosion due to damaged insulation

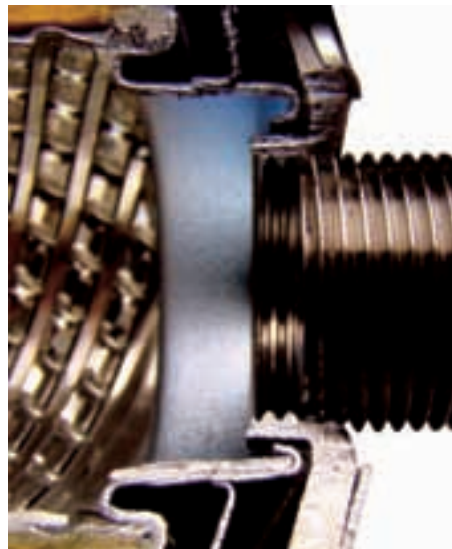
Fig. 2
Incorrect thread length due to loose conternut

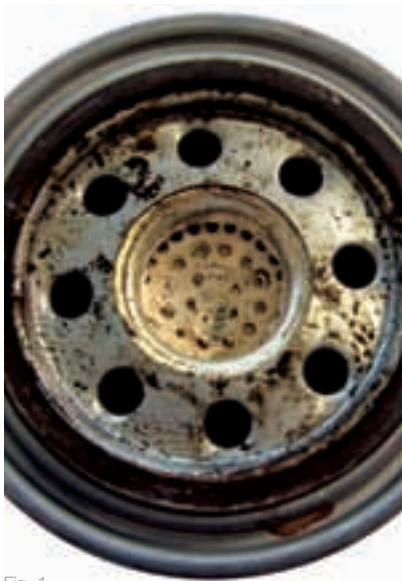
Fig. 1
Granules escaping from the air dryer cartridge
