ENGINE COMPONENTS AND FILTERS: DAMAGE PROFILES, PROBABLE CAUSES AND PREVENTION

Technical Information

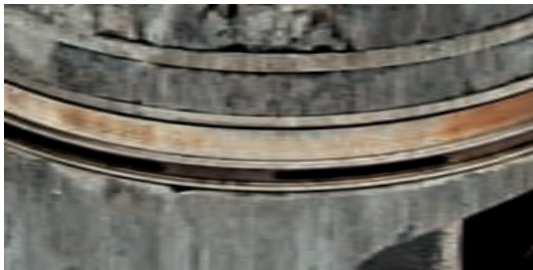
- The wear pattern is wide, shiny and shows deep scoring marks along the entire piston skirt (*Fig. 1*).
- Scoring marks on the piston rings, possibly additional burn marks on the piston ring surface (*Fig. 2*).
- The honing in the cylinder liner or cylinder running surface is heavily worn (*Fig. 3*).
- Heavy wear marks are visible at the piston pin. Pitting visible in the pin bore (*Fig. 4a+b*).

Fig. 2
Scoring marks and burn marks on the piston rings

- Set the injection system correctly (cold start enrichment, etc.).
- Check the injection nozzles.
- Installation dimensions must be observed.
- Always adhere to fuel filter maintenance intervals, and shorten the time between intervals accordingly in extreme conditions.
- Check the spark plugs and, if necessary, replace them.

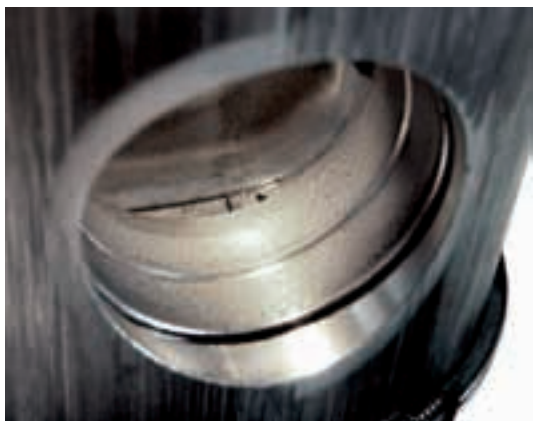
An excessive amount of fuel in the oil dilutes the oil film, thus drastically reducing its load-bearing ability and increasing engine component wear. This type of damage can have the following causes:

Fig. 4a
Pitting in the pin bore due to diluted engine oil

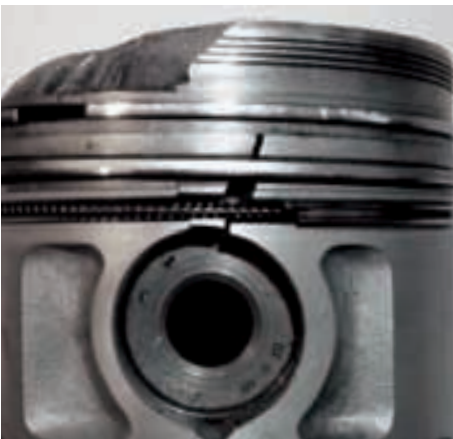
- The piston is broken or deformed (*Fig. 1*).
- The connecting rod is bent or broken (*Fig. 2*).
- The piston ring land of the piston concerned shows an overload fracture (*Fig. 3a+b*).
- The piston pin is broken.

This damage is caused by liquid. Water or fuel reaching the combustion chamber. Since neither water nor fuel can be compressed, hydraulic lock results in an abrupt stress load at the piston, the piston pin, the connecting rod, the cylinder head, the crankcase, the bearing and the crankshaft. Excessive liquid may reach the combustion chamber due to the following reasons:

Fig. 3a
Overload fracture from the top of the piston to the pin bore

- Always use new and undamaged gaskets when overhauling an engine. Defective gaskets must be replaced.
- Always check injection nozzles and, when necessary, renew them.

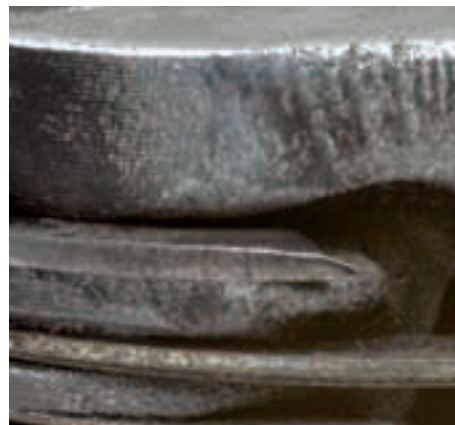
Fig. 1
Erosion at a gasoline piston

- Only use fuel with the specified octane rating.
- Set the injection system, the carburetor and the ignition correctly.
- Only use spark plugs which correspond to the manufacturer's specifications.
- Check the intake system for leaks.
- Use a thicker gasket for a re-machined cylinder head, and ensure the compression height is less for oversize pistons.
- Pay attention to the correct charge-air pressure for a turbocharged engine.

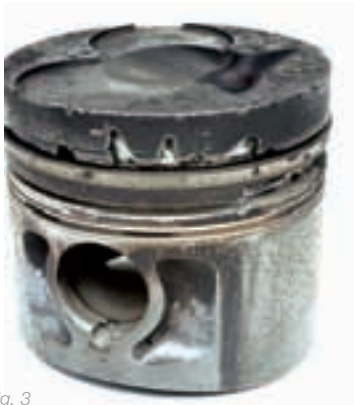
Fig. 3
Damage to the top of the piston due to individual fragments of the ring insert

- Always use a ring compressor during assembly.
- Check the piston ring grooves for wear prior to assembly. Always use a new piston if the piston ring grooves are heavily worn.

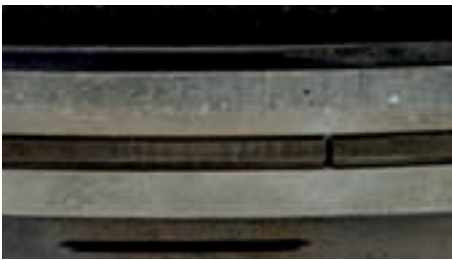
An excessive amount of fuel in the oil dilutes the oil film, thus drastically reducing its load-bearing ability and increasing engine component wear. This type of damage can have the following causes:

- The injection system is set incorrectly.
- The cold start enrichment is too rich.
- The injection nozzles are functioning incorrectly, for example due to a clogged fuel filter.
- Due to an excessive piston protrusion, the piston hammers the cylinder head, causing uncontrolled injection.
- The compression pressure is too low, which can result in misfiring. This can be attributed to the following conditions:
 - A valve is leaky.
 - The cylinder head gasket is leaky.
 - The timing is set incorrectly.
 - The piston protrusion is too small.
 - One piston ring or several piston rings are defective.
 - An error has occurred in the ignition system, e.g. a defective spark plug.

Fig. 1
Heavy radial wear with relatively low axial wear

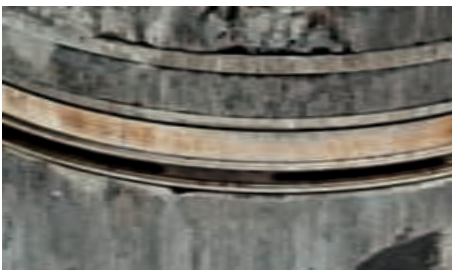
Fig. 2
Scoring marks and burn marks on the piston rings

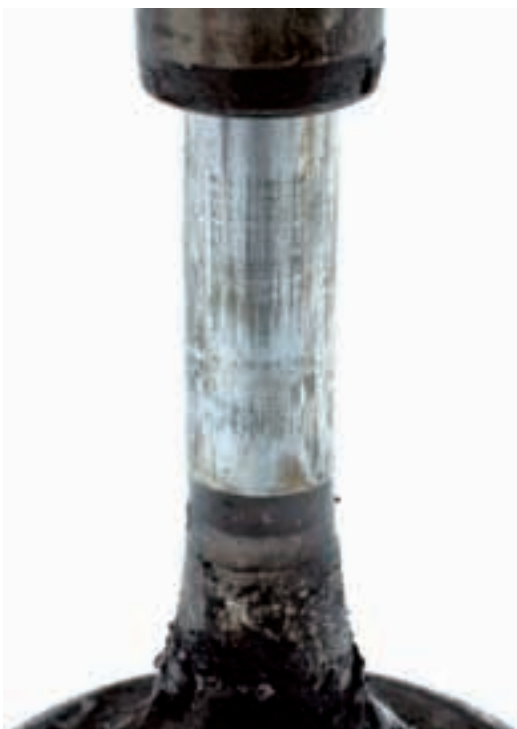
Fig. 1b
Clearly visible in the close-up view: Deposit build-up and seizure marks on the valve stem

- Align the valve guide and the valve seat correctly.
- When re-machining used valves, pay great attention to a straight valve stem.
- Install the valve seat inserts according to the manufacturer's specifications.
- Always use new valve keepers. Old keepers are usually worn unevenly so that the valves cannot rotate freely.
- Always machine valve guides to specified dimensions according to the manufacturer's instructions.
- After running the engine above the rated speed, it is advisable to check the entire valve train system and the top of the piston for damage.

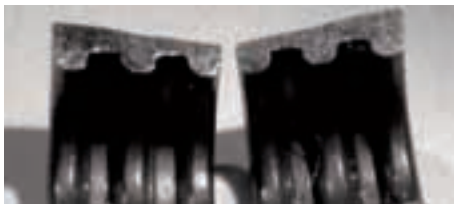
Fig. 3
Deformation of the valve keepers at the ribs

- Position the valve springs correctly during installation.
- Check the valve train system.
- Always use new valve keepers. Old valve keepers are usually worn unevenly so that the valves cannot rotate freely, resulting in bending stress at the valve stem.

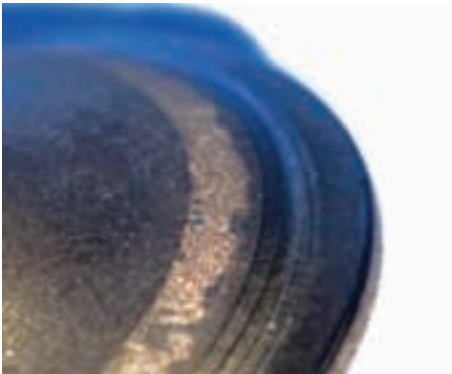
Fig. 1
Heavy wear on the sealing surface

- Make sure the valve guide and the valve seat are aligned.
- Set the valve clearance according to specifications.
- Only use parts approved by the manufacturer (springs, camshafts, etc.).
- The valves and valve seat inserts must be suitable for gas-fuelled operation (LPG, CNG, etc.).

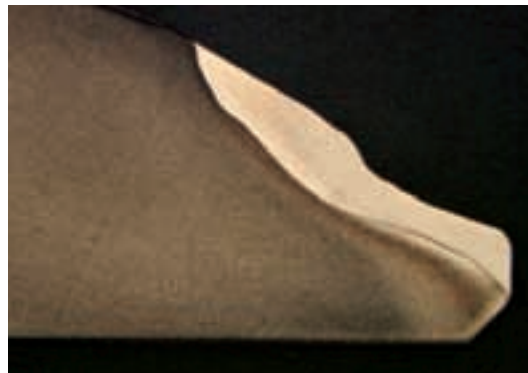
Fig. 3
Heavily worn sealing surface (stellite hardened)

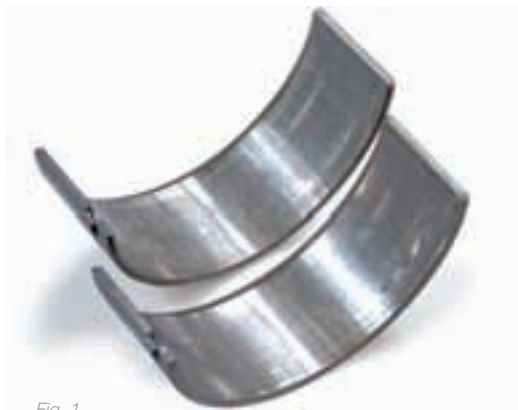
Fig. 1
Shiny marks on the running surfaces of the bearings

- The first indication is very shiny marks on the bearing (Fig. 1).
- During continuous operation with inadequate lubrication, the bearings first turn blue and then black (Fig. 2).
- In some extreme cases, the lining layer melts (Fig. 3) and the bearing welds to the bearing pin.

The bearing damage described above is caused by inadequate lubrication. With this type of damage it is important to determine whether just one or all of the bearings are damaged.

- Install the bearings according to the specifications. Pay attention to correct alignment of the oil feeder holes of the bearing and the oil feeder holes in the engine.
- Replace the oil and filter regularly according to the manufacturer's specifications – shorten the change intervals when using biofuels.
- Check the oil level and, if necessary, refill oil.

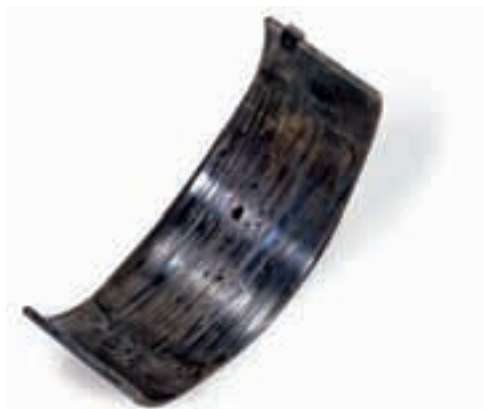
Fig. 2
Heavily worn and spun bearing

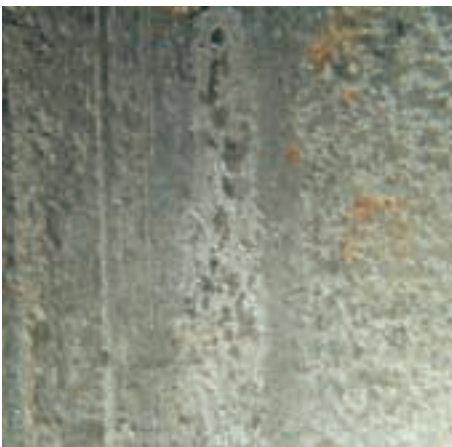
Fig. 1b
Clearly visible in the close-up view: The corroded bearing material

- Always carry out the oil change according to the manufacturer's specifications.
- Regularly check the cooling system for leaks or loss of water.

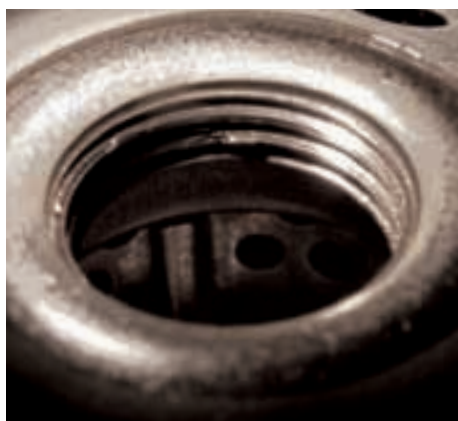
- The filter has been installed in a slanted position (Fig. 5).
- The o-ring is fitted incorrectly.
- An old o-ring has been re-used.
- The tightening torque was incorrect when installing the filter.

Fig. 5
Damaged threads due to an incorrectly installed filter
