ENGINE COMPONENTS AND FILTERS: DAMAGE PROFILES, PROBABLE CAUSES AND PREVENTION

Technical Information

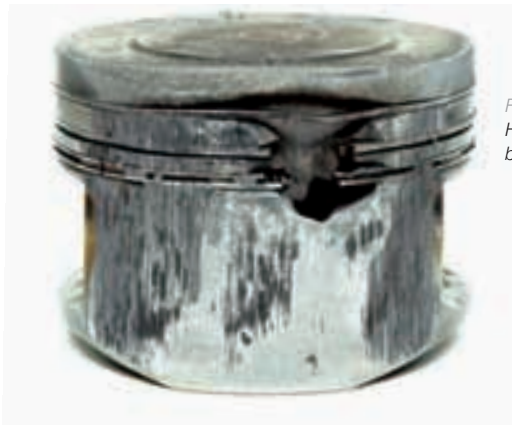
Fig. 4
Hole melted through the piston ring belt of a gasoline piston

- Only use fuel with the specified octane rating.
- Set the injection system, the carburetor and the ignition correctly.
- Only use spark plugs which correspond to the manufacturer's specifications.
- Check the intake system for leaks.
- Use a thicker gasket for a re-machined cylinder head, and ensure the compression height is less for oversize pistons.
- Pay attention to the correct charge-air pressure for a turbocharged engine.

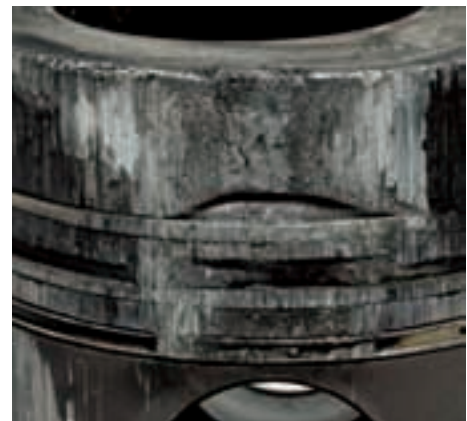
An abnormal combustion can be caused by a number of factors:

- The air-fuel mixture in the combustion chamber is too rich. This can be the result of the following:
 - The air supply is reduced, e.g. the air filter is clogged.
 - The fuel delivery is set incorrectly.
 - The start of fuel delivery is set incorrectly.
 - The nozzle needle is either wedged or stiff.
 - The exhaust gas system is clogged.
- There is ignition delay and misfiring which may be caused by the following:
 - The incorrect fuel or fuel with an insufficient cetane rating is being used, or there is gasoline in the diesel.
 - The valves are leaky, resulting in compression loss.
 - The protrusion is too small, i.e. there is insufficient compression.
 - The air pre-warming is defective (especially for very low ambient temperatures).

Fig. 1
Melting at the top land of a diesel piston

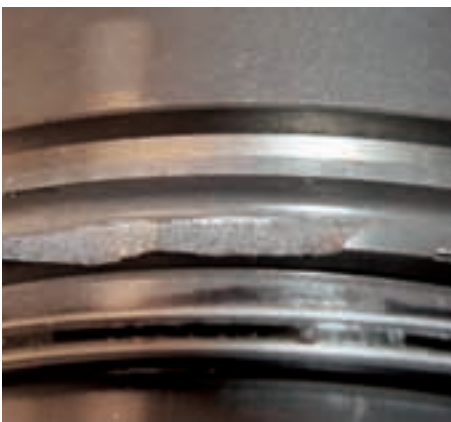
Fig. 2
Broken piston ring lands caused by an assembly error

- Only use fuel with the specified octane rating.
- Set the injection system, the carburetor and the ignition correctly.
- Only use spark plugs which correspond to the manufacturer’s specifications.
- Check the intake system for leaks.
- Use a thicker gasket for a re-machined cylinder head, and ensure the compression height is less for oversize pistons.
- Pay attention to the correct charge-air pressure for a turbocharged engine.
- Always use new and undamaged gaskets when overhauling an engine, and do not forget to replace relevant gaskets.
- Always check injection nozzles and, when necessary, renew them.

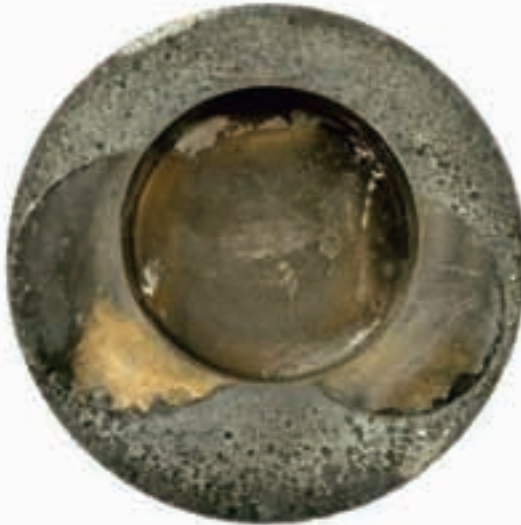
Fig. 2
Piston which has had contact with the cylinder head

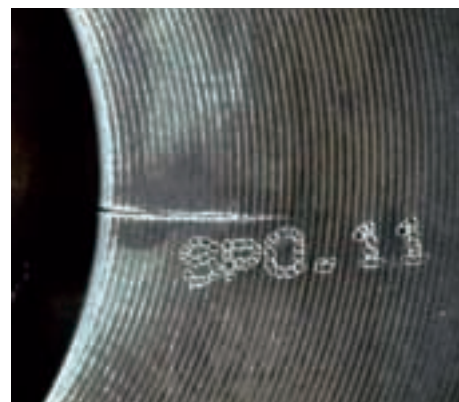
Fig. 3b
Close-up view

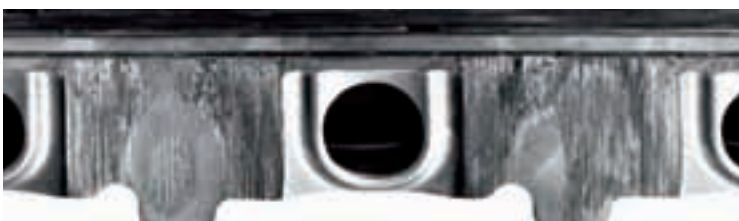
Fig. 1
Seizure at the piston skirt, caused by insufficient clearance

- Always observe the correct cylinder size. This can be determined using the values stated on the piston (piston diameter plus fitting clearance).
- Check the coolant circuit, this includes:
 - Coolant level
 - Water pump (V-belt)
 - Thermostat
 - Fan
- Deaerate the cooling system. This also includes the heating circuit.

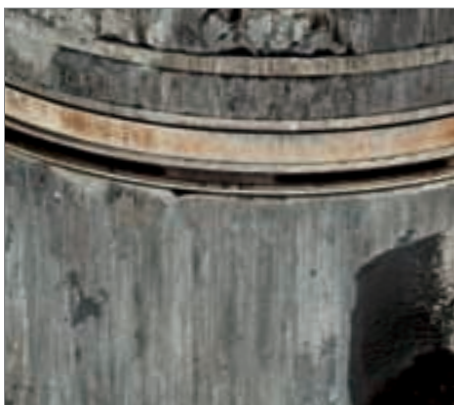
Fig. 2
Piston rings with burn marks

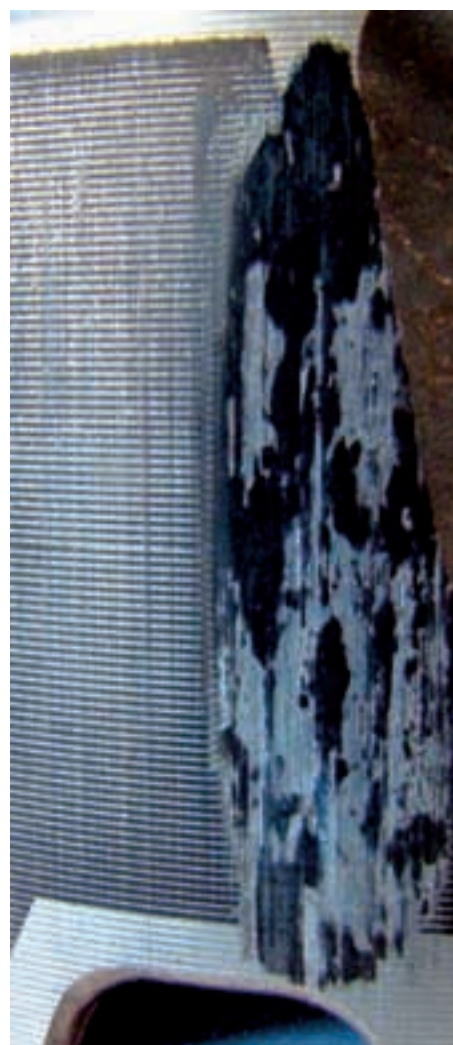
Fig. 1
Diagonal seizure marks next to the pin bore

- Always oil the connecting rod, the piston pin and the pin boss sufficiently immediately prior to engine assembly and make sure that unrestricted movement is guaranteed.
- Pump oil into the assembled engine under pressure to ensure that oil is pushed through the oil filter and all the oil feeder holes.
- Operate the engine at a moderate speed and load immediately after assembly.

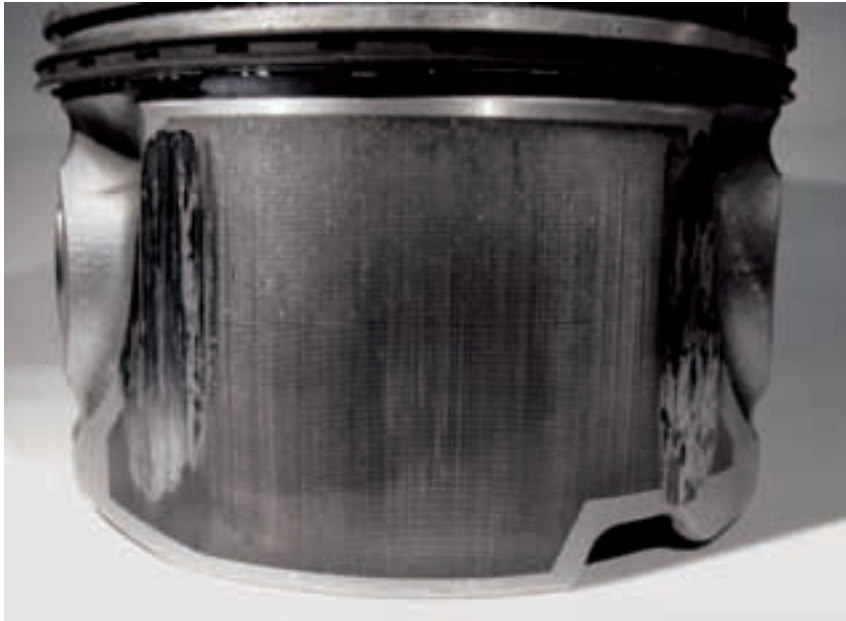
Fig. 2
Lateral piston seizure next to the pin bore

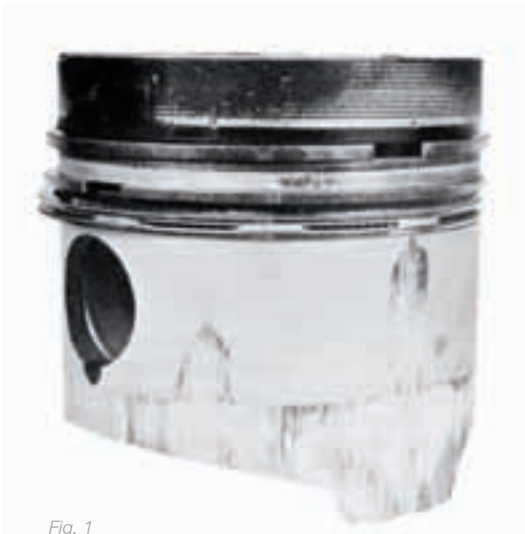
Fig. 1
Seizure at the lower piston skirt due to constriction of the cylinder liner

- Tighten the cylinder head bolts according to the tightening torque specifications.
- To prevent a lack of clearance or cylinder distortion, install wet cylinder liners without gaskets first. This ensures that a lack of clearance can be detected in good time. Subsequently insert the cylinder liner together with the gaskets.
- Set the honing machine correctly. Measure the cylinder bore at the top, middle and bottom, also in two directions, during and after honing.

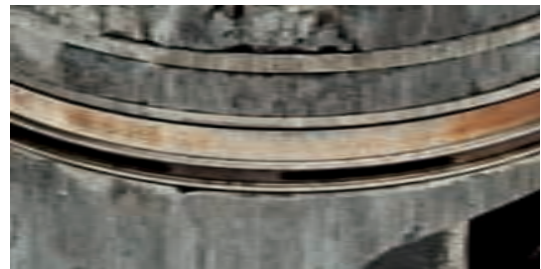
Fig. 2
Scoring marks and burn marks on the piston rings

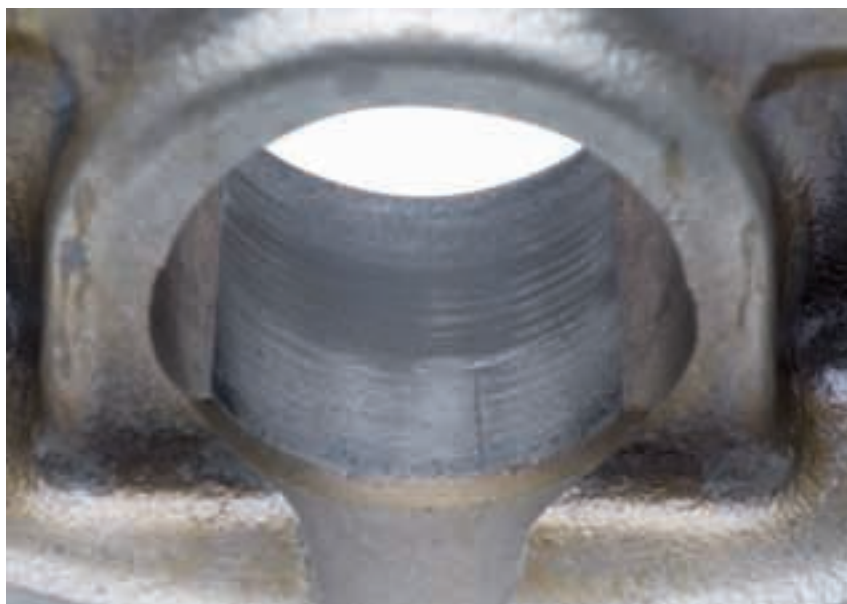
Fig. 1
Seizure in the pin bore

- During assembly, ensure there is sufficient clearance between the piston pin and the connecting rod bushing.
- Oil the piston pin sufficiently prior to engine assembly.
- Pay attention to the installation direction of the bearings (oil feeder hole, oil grooves).
- Only use engine oil approved by the engine manufacturer.

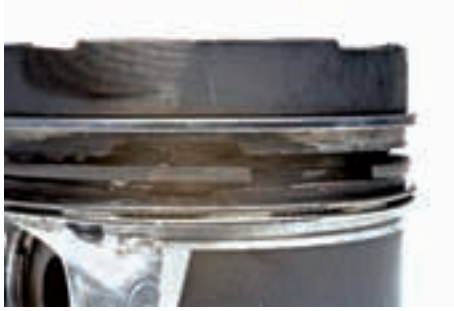
Fig. 1
Heavily worn piston ring groove

- Always use a ring compressor during assembly.
- Check the piston ring grooves for wear prior to assembly. Always use a new piston if the piston ring grooves are heavily worn.

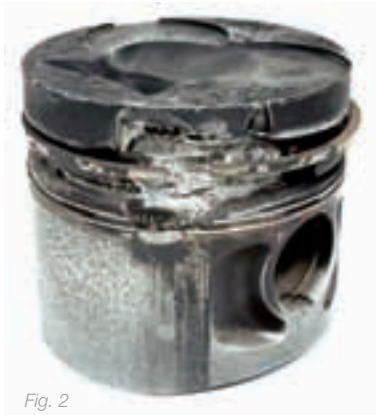
Fig. 2
Ring belt with shiny surface

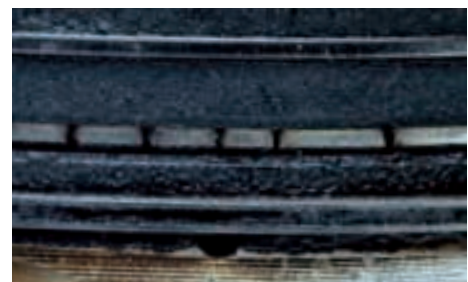
Fig. 4b
Close-up view of a piston ring fracture

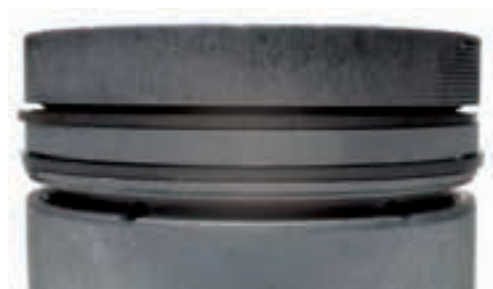
Fig. 2
Heavy axial wear particularly at the top ring

- Check the intake system for leaks.
- Check the air filter and, if necessary, replace it.
- Clean the crankcase and the intake manifolds prior to assembly.
- Always pay attention to cleanliness during assembly.

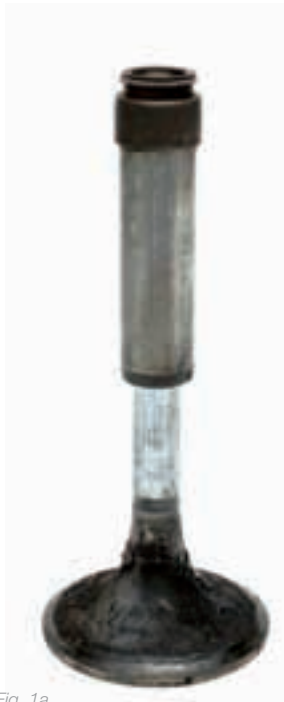
Fig. 1a
Valve with seizure in the guide

- Align the valve guide and the valve seat correctly.
- When re-machining used valves, pay great attention to a straight valve stem.
- Install the valve seat inserts according to the manufacturer's specifications.
- Always use new valve keepers. Old keepers are usually worn unevenly so that the valves cannot rotate freely.
- Always machine valve guides to specified dimensions according to the manufacturer's instructions.
- After running the engine above the rated speed, it is advisable to check the entire valve train system and the top of the piston for damage.

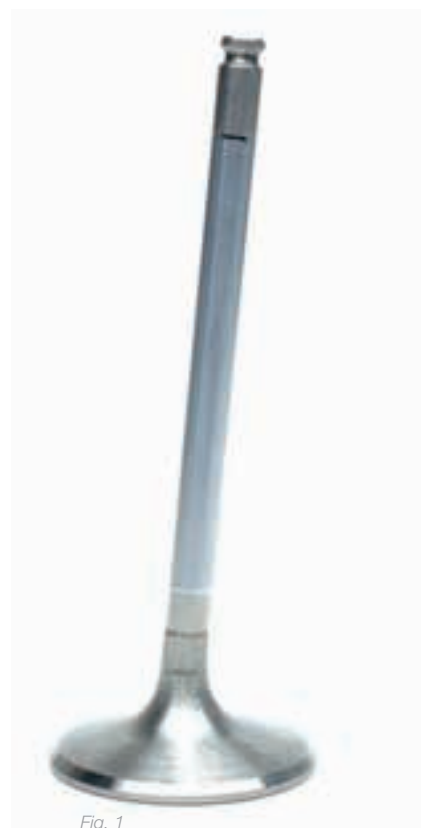
Fig. 1
Bent valve stem

- Set the valve clearance correctly.
- Avoid running the engine above the rated speed.
- Set the timing correctly.
- Always renew the clamping device when replacing timing belts or chains.
- After machining the cylinder head, always check the valve depth.

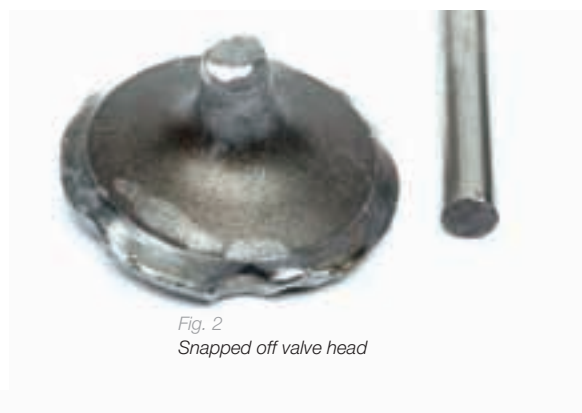
Fig. 2
Snapped off valve head

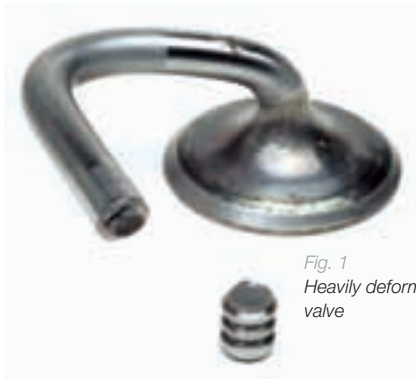
Fig. 1
Heavily deformed
valve

- Position the valve springs correctly during installation.
- Check the valve train system.
- Always use new valve keepers. Old valve keepers are usually worn unevenly so that the valves cannot rotate freely, resulting in bending stress at the valve stem.

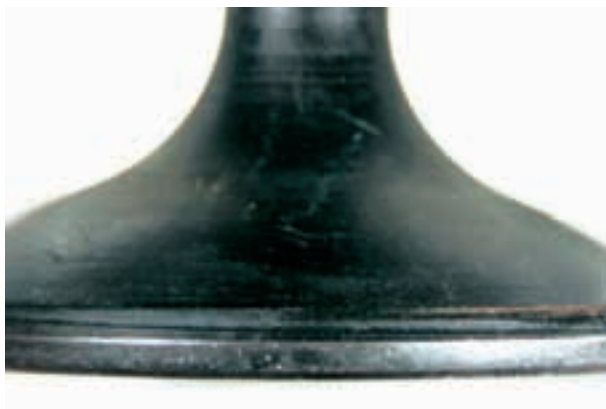
Fig. 1
Deformed valve head (tulip-shaped)

- Set the valve clearance correctly.
- Check the injection system.
- Always remove any remaining small parts from the combustion chamber or intake passage during engine assembly.

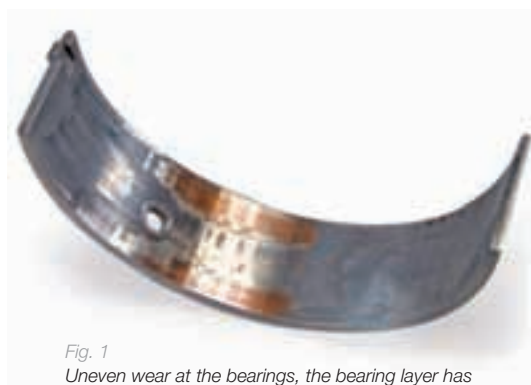
One or several bearings show uneven wear patterns – either only on the edge or only in the center of the bearing (Fig. 1–2).

This type of damage is caused by geometrical irregularities at the connecting rod and/or the crank pins. These irregularities create high surface pressure either in the center of the bearing or at the outer edges, resulting in an uneven wear pattern at the bearings. This can be attributed to the following:

Fig. 1
Uneven wear at the bearings, the bearing layer has been partially removed

- Always check the correct angle of the connecting rods prior to installation and, if necessary, align them.
- Cylindrically grind the crankshaft pins.

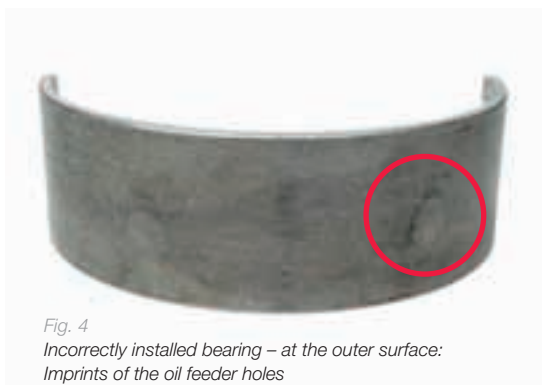
Fig. 4
Incorrectly installed bearing – at the outer surface:
Imprints of the oil feeder holes

- Only one half of the bearing has oil feeder holes. If these bearings are installed with the incorrect orientation, the oil feeder hole (Fig. 4) of the bearing seat is closed and oil cannot reach the bearing.
- Clogged oil feeder holes cause inadequate lubrication. The use of bio-fuels poses a particular risk of oil clouding and thus clogged oil feeder holes.

- Install the bearings according to the specifications. Pay attention to correct alignment of the oil feeder holes of the bearing and the oil feeder holes in the engine.
- Replace the oil and filter regularly according to the manufacturer's specifications – shorten the change intervals when using biofuels.
- Check the oil level and, if necessary, refill oil.

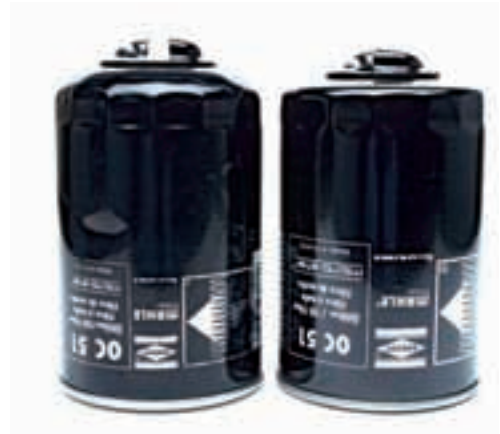
Fig. 2
For comparison: Swollen filter (left) and new filter (right)

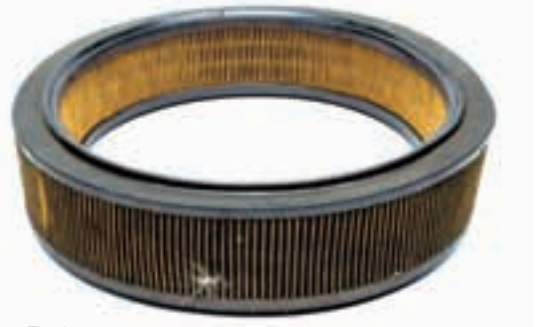
Fig. 3a
Extremely dirty air filter element, filter change imperative

- Always use filters approved by the manufacturer.
- Always adhere to the change intervals.
- If necessary, deaerate the system when replacing the fuel filter.
- Check the fuel lines for leaks.
- Change the air filters according to the manufacturer's specifications; or earlier if heavy soiling occurs.
- Carefully clean the sealing surface in the housing when changing the air filter.
- Check correct functioning of the mass air flow sensor.

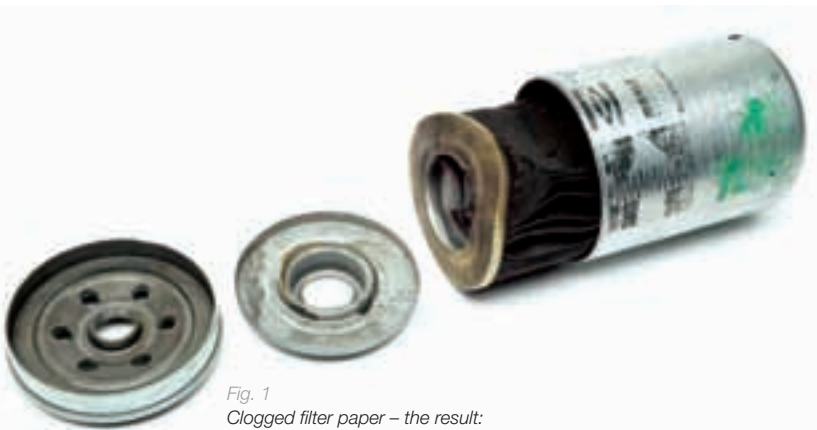
Fig. 1
Clogged filter paper – the result:
Collapsed filter element

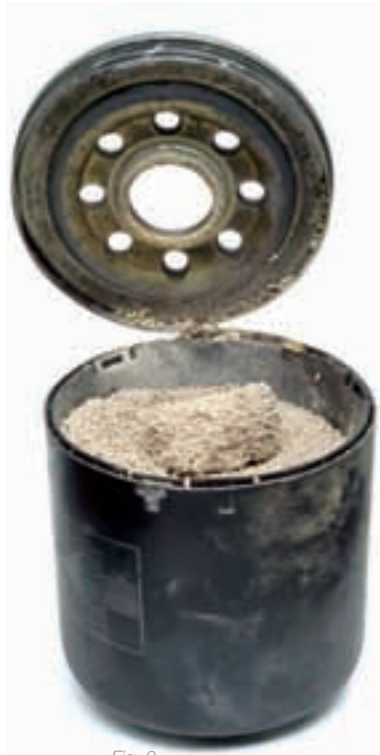
Fig. 2
Lumpy granular material
